Restoration of Capella da Nossa Senhora do Monte Old Goa

Luis Soromenho Marreiros

1. ABSTRACT

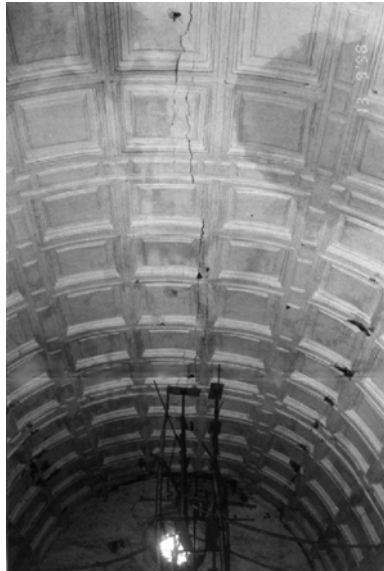
Figure 2: Interior view of the Nave vault – showing the crack

Around 1980 it was noticed that the vault had developed a crack in the longitudinal direction. Over time this crack widened causing dislocation of some of the laterite stones and two or three of them separated and fell to the ground. Timely temporary propping of the vault prevented further collapse as seen in Fig.2. It was in this condition that the local parish approached the Fundação Oriente, a Portuguese cultural trust to take up the restoration works. The Fundação Oriente appointed me as the technical director and project responsible after having contacted IPPAR.. Locally, conservation architects (Bombay Collaborative) in association with structural engineers (Sewri Consultants) were commissioned to form a complete technical team to plan and execute the restoration work.

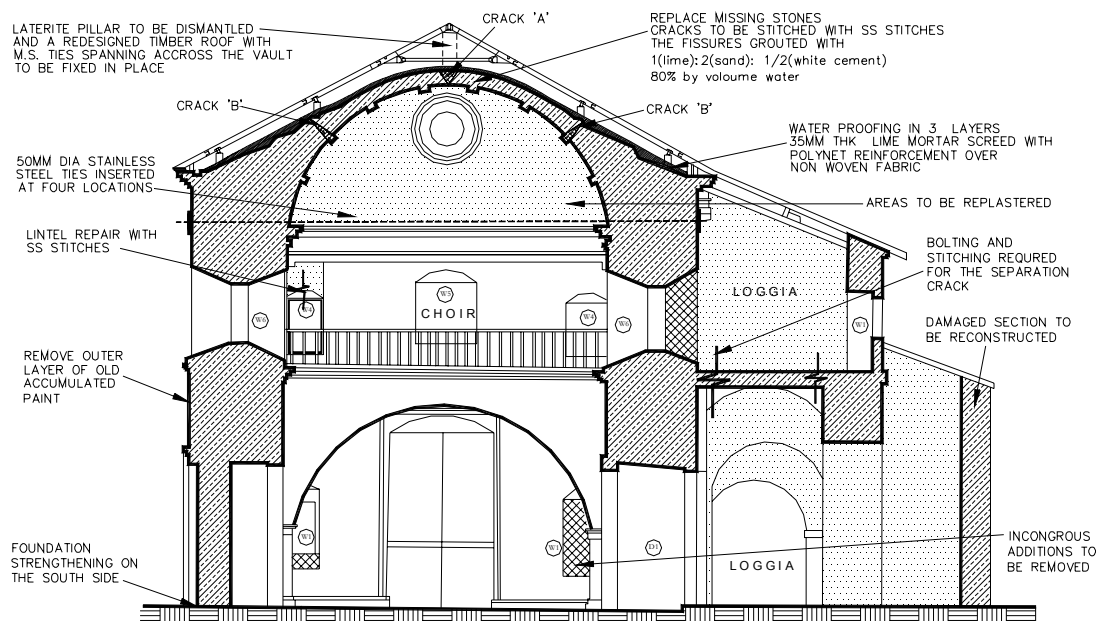
The monument became a topic for discussion and finally a subject for undertaking restoration work when a longitudinal crack (A) as seen in the Fig.3 was noticed. This crack extended longitudinally throughout the length of the vault. The other cracks, at the quarter points of the arch of the vault (B) were also clearly visible. These were seen as hairline cracks from the inner side, whereas the stone had clearly separated at the outer surface, i.e. the barrel arch had developed a central longitudinal crack, where the inner face (interados) was in tension and outer face (exterados) was in compression. In the case of the longitudinal cracks along the quarter points of the barrel vault, however, the interados were in compression and the exterados were in tension. As a result of this cracking pattern, the entire vault was in structural distress. Strengthening and rehabilitation of the vault was one of the main structural design problems to be tackled.

Figure 3: Section showing the cracking of vault schematically and all the other Structurally distressed areas

It was noticed that the south wall was out of plumb by nearly 100mm.

The gable ends on either side of the nave had separated.

The lintels of the windows on the west façade had cracked due to a lateral crack running across the façade.

The Loggia, which was a later addition, showed signs of separation from the main building.

From all the signs of structural distress it was clear that there had been some movement caused to the foundations. The exact reason why this had occurred could not be ascertained. The reason for this foundation movement could be settlement of foundations, deterioration of laterite rock used as the material of construction in the foundation work over a period of time, or even effects of earthquake tremors. Sliding of the hillock slope as a possible reason was

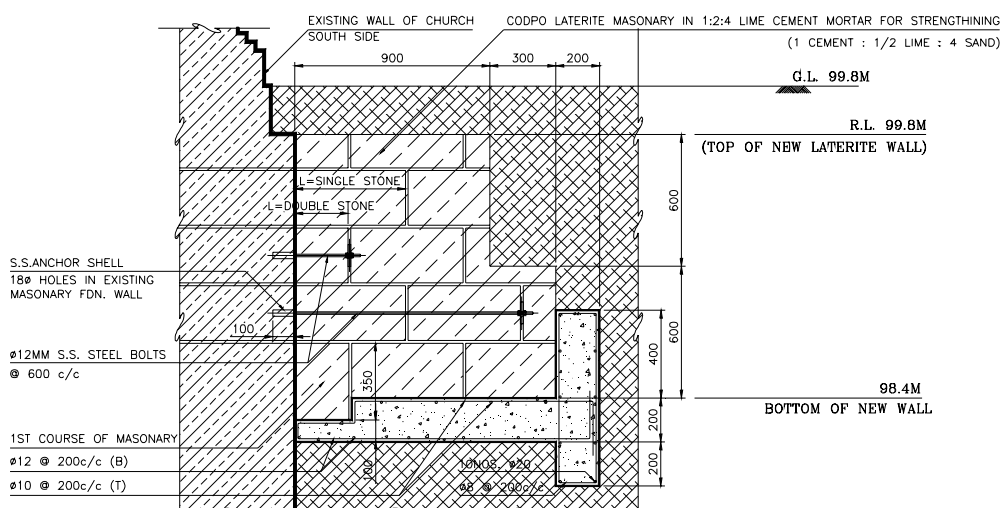
Figure 4: Drawing showing the foundation strengthening detail wall.

The design concept to strengthen and buttress the existing foundations was to add extra mass by the side of the existing foundation, attach the new mass to the old foundation by means of S.S. anchor bolts and ties and create a foundation system, such that the entire foundation does not move laterally. As far as vertical settlement of the Chapel wall is concerned, it was assumed that since the foundation has been constructed on laterite rock of the hillock, vertical settlement is not the main issue and whatever vertical settlement was to take place, has already occurred. Adopting a cautious approach underpinning of the existing foundation was thus not attempted. The original laterite rock, of which the foundation was constructed, appeared to be fairly intact and had not crushed or deteriorated over time. In keeping with this design philosophy, the foundation design system as seen in Fig. 4 was adopted for the south wall. A similar system was adopted for the two buttresses on the north wall.

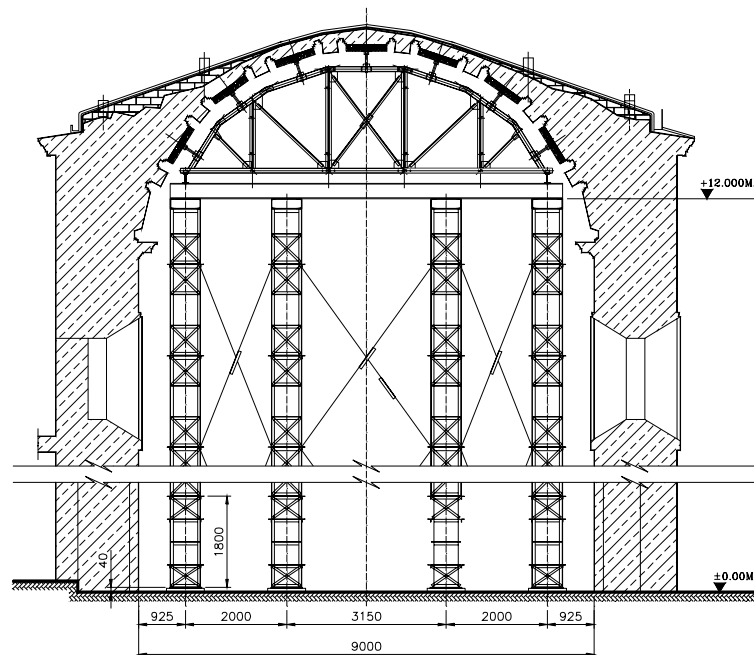
Figure 5: Drawing showing the temporary supporting system

Fig. 5 shows the temporary supporting system designed to support the vault during the process of vault structural consolidation. The system consists of structural steel trestles, on which structural steel arch trusses were erected. The trusses had a provision for attaching, adjustable stirrup head jacks in which timber scantlings, could be placed. These timber scantlings supported plywood formwork plates. Between the vault underface and the plywood formwork plates was sandwiched a layer of 100mm thick foam. The stirrup head jacks were adjusted so that the plywood formwork plates supported the load of the vault surface, with the foam sandwiched in between. The reason for introducing the foam layer, was to ensure that the offsets of the coffers on the underside of the vault, are not damaged.

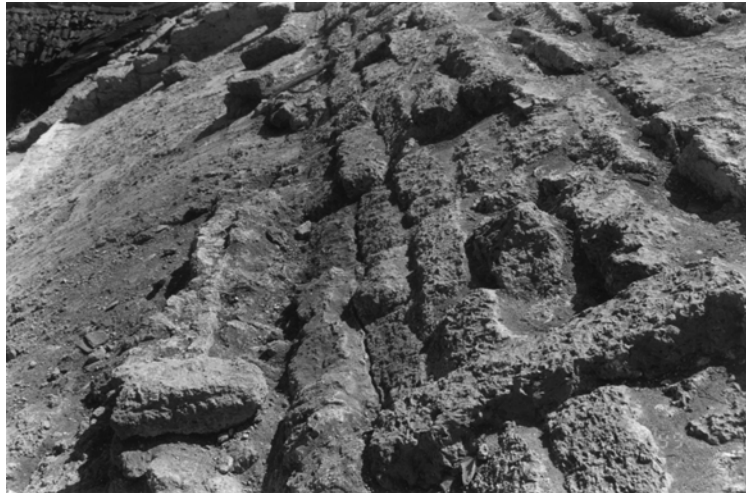
Figure 6: Photograph showing the vault surface when exposed with the timber roof dismantled

With the vault firmly supported, the next step was to grout and stitch the cracks from above. To achieve this, the entire timber roof above the vault was dismantled and the upper surface of the vault exposed as seen in Fig. 6. The exterior surface of the vault was cleaned and the cracks were located and exposed. It was observed that the cracks ranged from 20mm to 50mm in width. The first step was to refix the dislocated stones. Then the cracks in the vault and the portion which had separated from the gable walls were stitched, with the use of stainless steel stitches. (The various types of stainless steel stitches used in this rehabilitation work are described later in the paper.) Subsequently a pointing mix of [1 part lime: 3 parts sand + 5% Acrylic resin] was used to fill the cracks.

Having restored the vault to this extent, further strengthening was carried out by means of general overall grouting of the vault surface / profile by means of drilling holes, fixing an appropriate nipple and attaching a grout feeder pipe to pass the grout into the main body of the vault. Various mixes of the grout were experimented and tested earlier in the laboratory and later verified for site conditions by means of field tests, before being adopted for work at site. The grout mix finally used was [1 part lime: 2 part sand passing 600 microns: ½ part white cement: 80% water by volume (Unit volume = lime + sand + white cement)] The grouting operation was carried out under a very low gravity feed pressure (maximum 0.1N/mm²). The entire vault consumed nearly 5m³ of grout. After the consolidation of the vault it was necessary to load it with the appropriate weight. In that order, a sandwich of the following materials was executed:

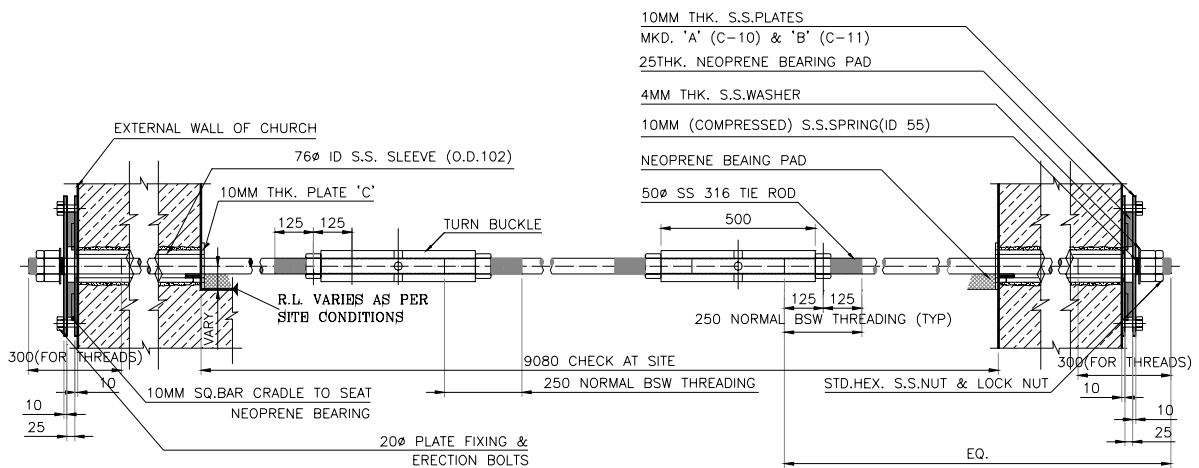
Figure 7: Detail of the ties

While this process was in progress, four horizontal holes were drilled through the 2.7m thick north and south walls exactly opposite each other, to place stainless steel ties as tension members, to prevent any lateral movement of the walls. The detailed design of the S.S. ties is shown in Fig. 7.

The ties mainly consist of a stainless steel bolt SS 316, 50mm in diameter in three parts joined by two intermediate turnbuckles. The holes drilled, were lined by a stainless steel pipe 6mm thick as a liner. The ends of the ties abutted against the wall face by means of two stainless steel plates 8mm thick, with neoprene bearing pads as a sandwich layer. The neoprene pads were placed to permit slight movement in the system / bolt, that might occur due to difference in temperature, or lateral forces like earthquake tremors etc. The end of the bolt was anchored by means of a hexagonal nut, tightened till refusal and followed by a lock nut. The entire bolt / tie assembly as erected and placed under the vault is shown in detail in Fig. 8.

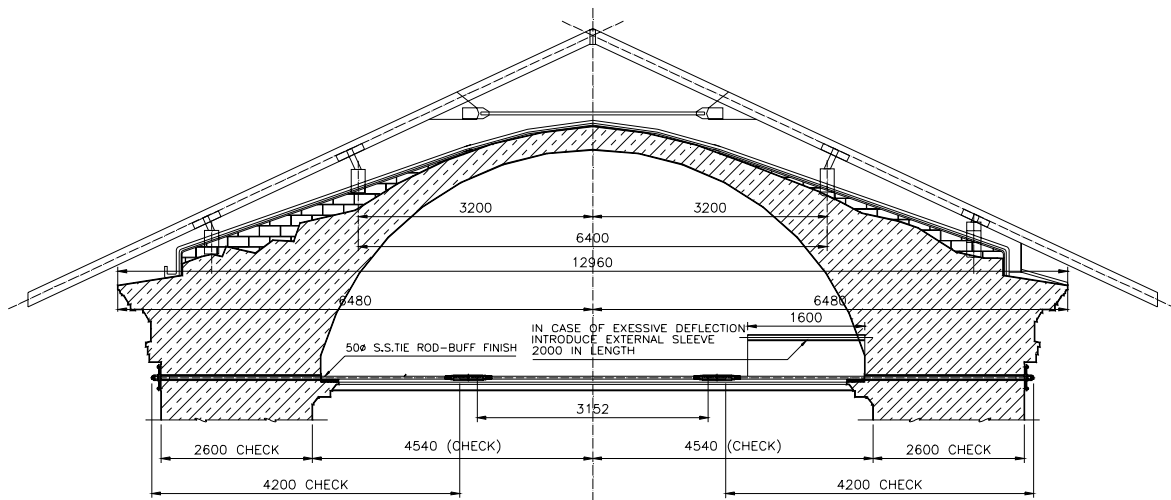
Figure 8: Entire S.S. Tie Assembly as erected and placed under the vault

In the case of the original roof, the main rafters spanned from laterite pedestals placed on the crown of the vault to those on the side. Thus, vibrations induced into the roof structure due to wind load were transmitted on to the vault. While redesigning the roof framework, the laterite pedestals on the crown of the vault were eliminated and instead, a horizontal mild steel tie was introduced to span across. Thus the wind load is transmitted to the sidewalls of the Chapel which are about 2.7m thick. The barrel of the vault, hence, is protected from unnecessary vibratory loads. All nails and screws piercing the timber, are of S.S. 316 grade, to avoid any splitting of the timber due to corrosion. Fig. 8 also shows the arrangement of the timber truss forming the new roof design.

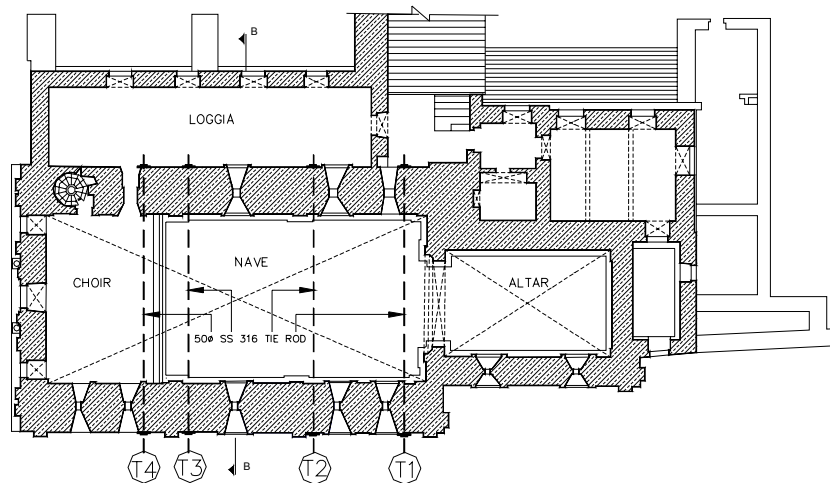
Figure 9: Key plan showing location of the ties

Four such ties were placed in the entire vault, at convenient locations as seen in the key diagram as shown in Fig. 9.

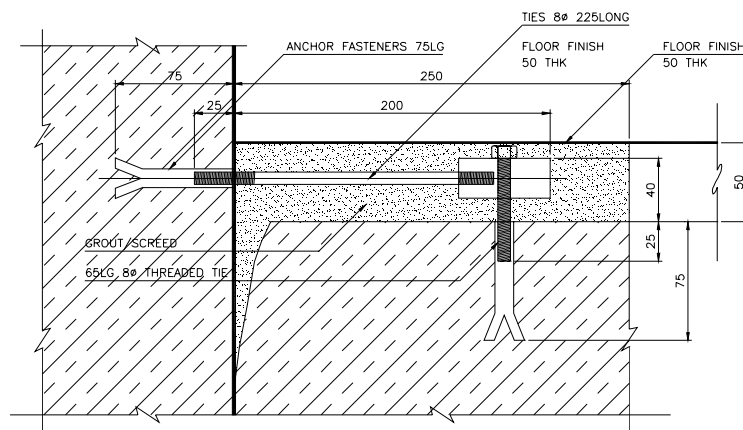
Figure 10: Detail of stitch between a vertical wall and the Horizontal plane

Different stitches were designed for appropriate locations, as required. The stitch as shown in Fig. 10 was necessary where the vertical walls and the horizontal planes of the vault or the floor slab had separated. This had occurred where later additions like the loggia had separated from the main Chapel. Due to the movement in the foundations the gable walls showed signs of separating from the vault profile.

To describe the stitch, an anchor fastener is placed in a vertical wall and a tie is screwed in to it. The end of the tie has a flat plate with an eyehole drilled into it. An anchor fastener is then drilled in to the horizontal surface in alignment with the eyehole of the flat plate. A vertical tie is now threaded through the eyehole and a nut is tightened on the faceplate by means of a hexagonal nut. Thus a vertical surface gets anchored to a horizontal surface.
