Vulnerability of Cultural Heritage to Hazards and Prevention Measures

Defects and Damage on Historical Buildings Caused by Neglecting and Improper Management

Ing.arch. Marek Sarissky

Institute for Monuments Bratislava, Office Bardejov.

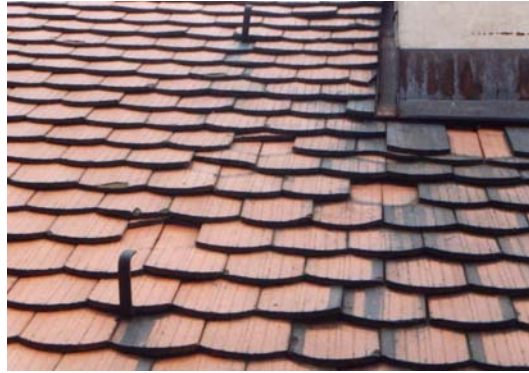
Not only the quality of roofing material is important, but regular maintenance as well. Also simple defects will cause serious damage - House No. 39 on The Town Hall square – Bardejov

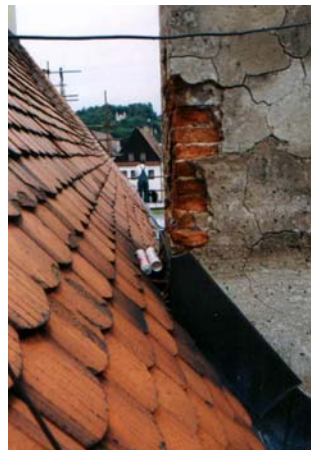
When places where vertical construction penetrates roof cover are not maintained regularly, serious damage can occurred. - House No.38 on The Town Hall square – Bardejov

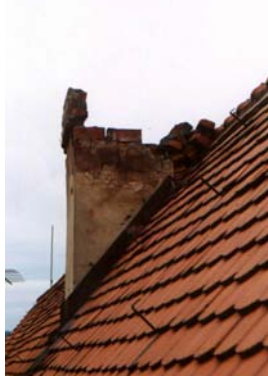
Bricks falling from the top of chimney are dangerous for roofcover. - House No. 38 on The Town Hall square – Bardejov

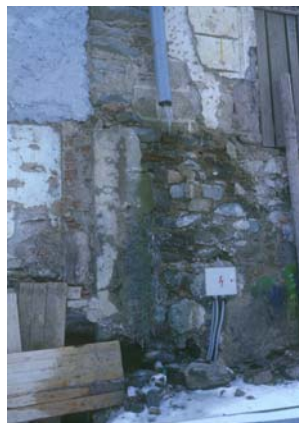
More than 20 years missing downpipe is continuously damaging walls, foundations and ground soil. - House on The Trinity square – Banska Stiavnica

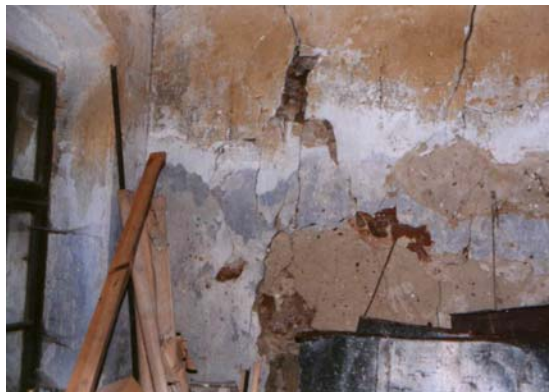
Cracks on the wall occurred during construction works on neighbouring house. Although they are not moving any more, they must be maintained, not to cause more damage. - Jewish synagogue on Klastorska street – Bardejov

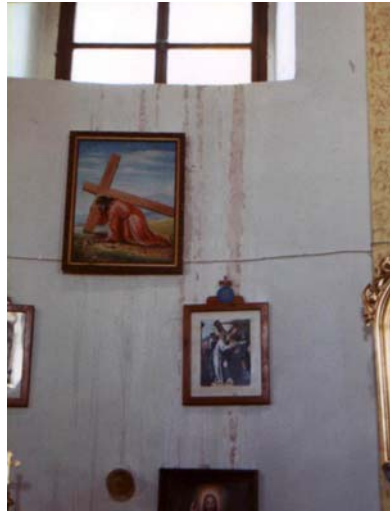
Water condensation on the window glass sheet causes damage to painting, plaster, and to window frames as well. - Greek-catholic church of Virgin Mary in Chmelova

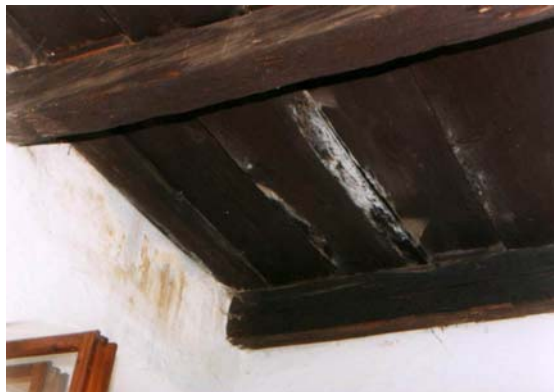
Mould on the wooden ceiling indicates high humidity above the ceiling. - Building on Town Hall square 3A, Bardejov

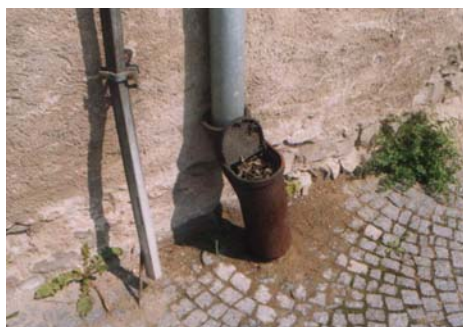
Very simple activity – cleaning certain points on drainage system - can avoid many problems. - House in Town reserve Litomerice

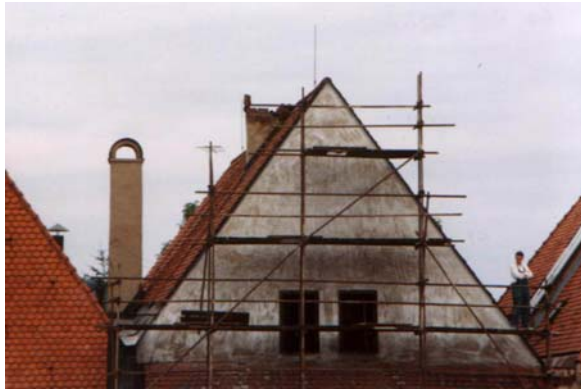
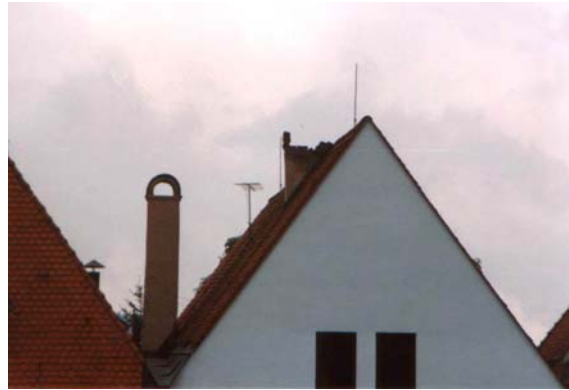
Repairing of the plaster of main facade was finished without repairing of deteriorated top of the chimney. House No. 38, Tawn Hall square, Bardejov before and after repairing of main façade.

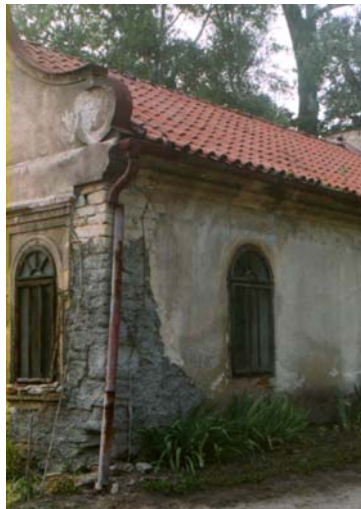
Although there were some maintenance activity done, they are not sufficient since they were related to consequence not to cause of the damage. - Garden house of the castle at Liblice

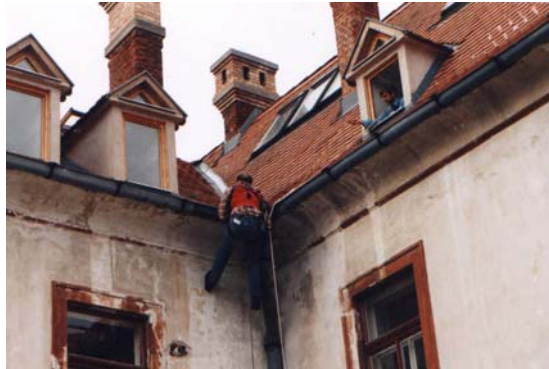
Inspectors beside preparing reports can provide „first aid“ repairs - Team of Monumentenwacht Netherlands inspects Palffy's manor house in Svaty Jur.

In the year 1973 was in the Netherlands founded an organisation “Monumentenwacht” with the goal to implement the idea of regular preventive maintenance through cyclical technical inspection and “first aid” repairs of the historical buildings. Today Monumentenwacht Netherlands yearly inspect 25% of all listed buildings in The Netherlands. They initiated the changes in governmental policy of subsidising of protection and restoration of monuments. From subsidising of large restoration projects towards supporting regular preventive maintenance. Later on, the approach of Monumentenwacht Netherlands becomes a model for similar activities in different European countries (In Flanders Monumentenwacht Vlaanderen, in Germany Denkmalservice, in Denmark Raadvads Bygningssyn and the idea is developing in other countries of the Europe).
