Analysing indoor Climate in Building Heritage in Slovenia

Marjana ŠIJANEC ZAVRL¹

ZRMK, Technological Building and Civil Engineering Institute, Ljubljana, Slovenia

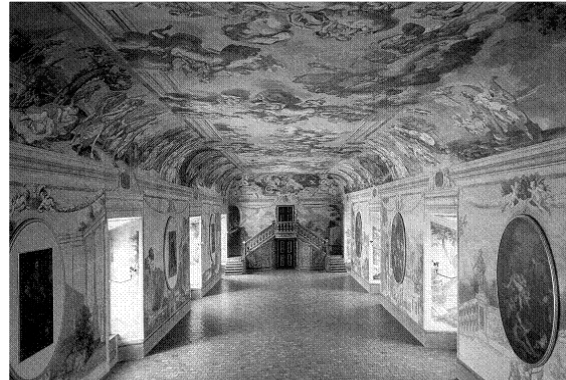
Figure 2. Knight Hall in Brezice castle.

The large Knight Hall is 31.1 m long, 9.6 m wide and 7.8 m high (Figure 2). It stretches over the first and second floor of the eastern wing of the castle. The ground floor under the Knight Hall is used as a vine cellar. The castle walls are built of massive stone masonry. Their thickness is gradually lowering from ground floor up to roof. Outer walls are thicker than walls oriented to the courtyard. The roof construction and ceilings above the Knight Hall are made of timber. The timber beams of ceiling are plated with wooden boards thatched with reed that carry about 40-mm thick multi-layered plaster. To preserve the fresco painting quality, several preventive activities have been undertaken in the last decade. Since in the last years progressive fresco deterioration has been found in area of stairways the main idea was to assess the impact level of the outdoor air temperature and relative humidity and indoor climate changes because of the events. The main every years events in the Knight Hall are every second evening concerts in August with audience of about 300 persons.

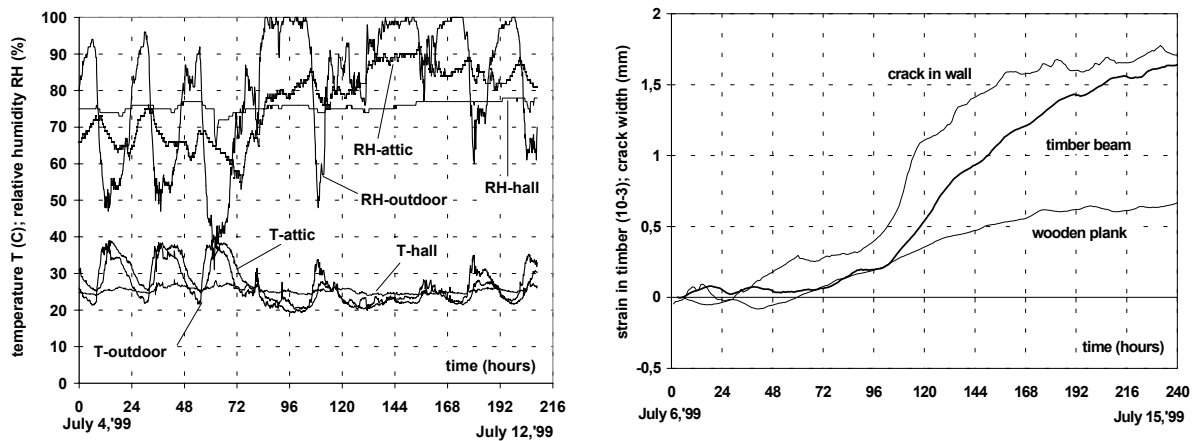
Figure 7. The results of measuring of outdoor and indoor temperature, relative humidity, of timber expansion and crack propagation in the attic of Knight hall

The cracks propagation in painted plaster and in structural walls generated by permanent expansion and shrinkage of timber structure. The significant deformations are caused after long dry period when intensive humidity expands the floor timber structures and ceiling planks. Diagrams in figure 7 illustrate the case of rapid alternation of microclimatic conditions inside the attic of Brezice Castle due to summer showers that followed the long dry period. The increase of outdoor humidity and lowering of temperatures was followed by increase of humidity and lowering of temperature in attic. However, the microclimatic conditions did not changed significantly in hall below the attic due to better insulation from outdoor influence. The elevated humidity of attic caused the expansion of timber joists that are fixed atop of facade walls and consequently the widening of existing cracks in perpendicular walls. This influence can be diminished by rearrangement of joists' supports. The wooden planks expanded as well causing some influence on the ceiling painted plaster although the part of deformations can be compensated by reed. The data gained from future permanent several years measuring campaign are expected to provide information needed for assessment of influence of timber dilatation on decay of painted plaster.

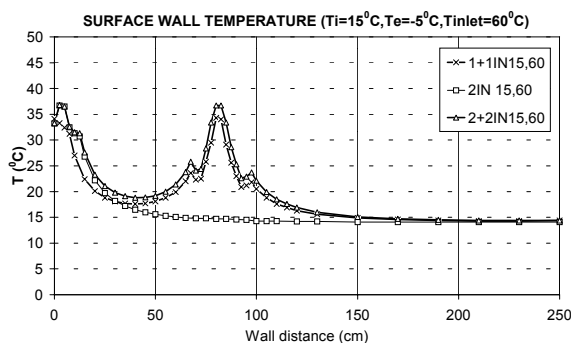
Figure 9. Comparison of wall surface temperature for different distribution of pipes.

The surface temperature in the lower part of the surrounding walls for various pipes positions were compared (Figure 9). The case with two pipes in-built in the wall in two layers (see Figure 10) was selected. The target indoor air temperature 15°C with average temperature of bottom part of surrounding surface 19.7°C was expected to results in the effective indoor temperature around 17°C , convenient for exhibition areas. In case of occasional events in the room internal heat sources from occupants or additional heating device used only for a short time period can meet thermal comfort requirements. Simulation of the temperature field in the walls and of the indoor air temperature in rooms for the whole tower 1 showed good matching with the measured values.

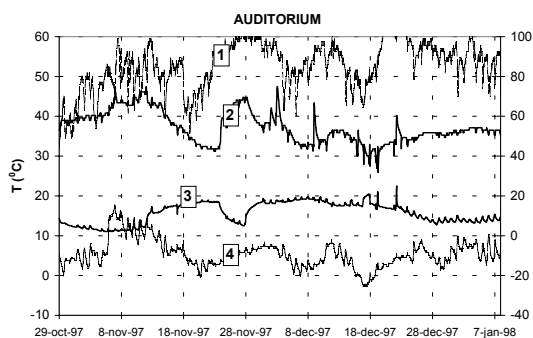
Figure 11. Temperature and relative humidity in the round room in the tower 1 – auditorium, heated by wall tempering system. Diagrams show outdoor (1) and indoor (2) relative humidity, outdoor (4) and indoor (3) temperature.

Microclimatic parameters were monitored (Figure 11,12,13) to validate the wall tempering impact. The test run of the heating system in the round room (1) started in the middle of November 97 (Figure 11) and stopped on November 26 due to finishing works – restoration of wall plaster. The plaster drying process was finished on November 28. After that the room was heated only by the heat from the in-built pipes and stored in the wall, the radiators were closed. Outer air temperature in the first half of December was lower than in the second part. Therefore the inlet water temperature, controlled by the central regulation was higher (above 60°C) in the first part and lower (58°C) in the second part of December. As the outdoor temperature moderately raised the indoor air temperature was reduced from 20°C to 15°C . Corresponding drops and raises in relative humidity show the opportunity for establishing appropriate stable microclimatic conditions for exhibition areas.

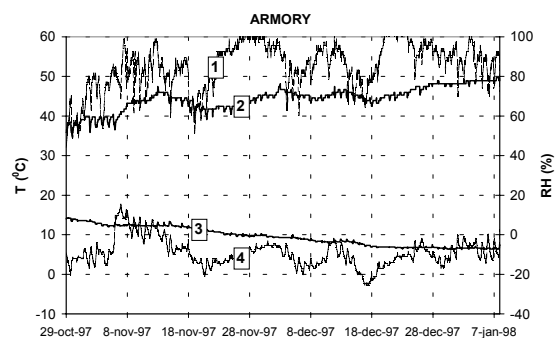
Figure 12. Temperature and relative humidity in the unheated reference room, armory exhibition room in the tower 2. Diagrams show outdoor (1) and indoor (2) relative humidity, outdoor (4) and indoor (3) temperature.

Microclimatic data for the reference room (Figure 12) showed to high level of relative humidity for the collection of arms (up to 80%) which is in correlation with seasonal

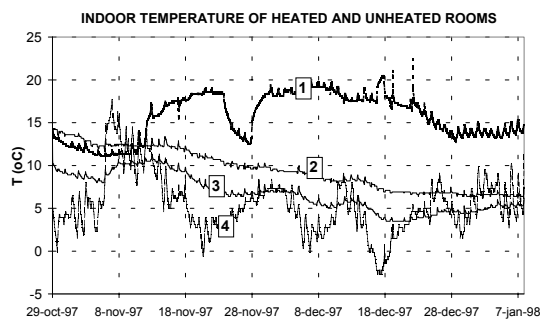
Figure 13. Temperature of the round room (1) heated by wall tempering, reference unheated room (2) and unheated Knight hall (3) compared to outer air temperature (4).

Temperature flows of the rooms 1 and 2 were compared with the Knight hall (Figure 13). The temperature oscillation and in general lower temperature can be observed in the hall, due to relatively bigger windows, less compact form and less heat storage capacity of the hall.

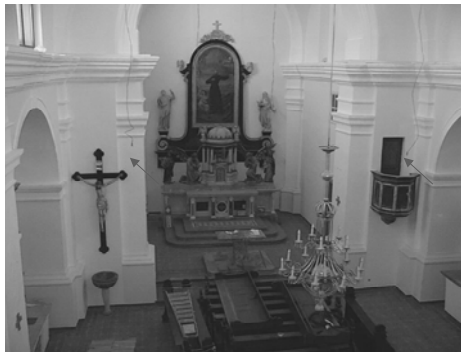
Figure 15. Parish Church St. Tilen in Mokronog, position of temperature sensors.

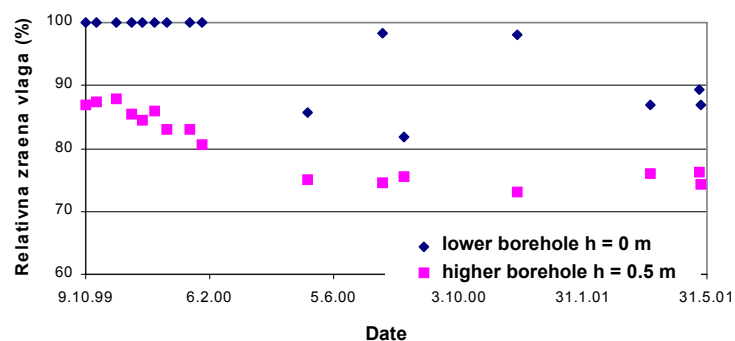
Figure 17. Equilibrium relative humidity of the air in a borehole 10 cm below the inner wall surface in case of drying of wet walls by wall tempering, Teharje church, [13].

Indoor air temperature and relative humidity was measured in both churches, in the figure 16 the seasonal measurements for Mokronog church are presented. Important additional effect of wall tempering is drying of the wet walls and reduction of capillary raise influence. The process of wall drying in case of all year round heating with the lower level of pipes was monitored and showed up to 15% reduction of equilibrium relative humidity measured in the sealed borehole in the wall 10 cm below the inner surface (Figure 17).

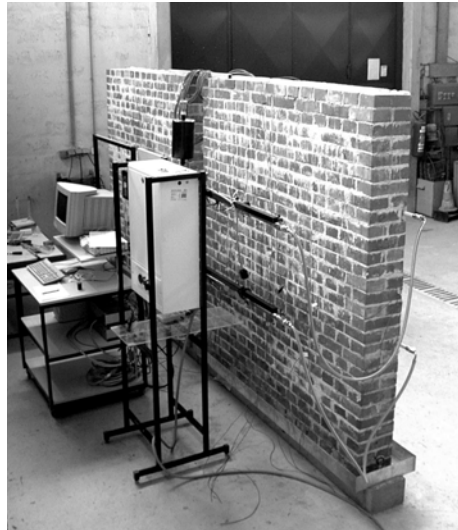
Figure 19. Laboratory testing of wall tempering performance.

To show the wall heating effects on prevention of damp raising in massive brick wall the laboratory experiment was prepared (Figure 19) where the drying process of the heated massive brick wall is monitored and compared with the energy used for drying the wall. Thus the potential for use of solar energy will be evaluated. To prove the energy saving potential also the consequent reduction of the U value shall be analysed. In addition the influence of the warming and drying process on contractions and cracks in different lime plasters, prepared according to the old recipes suitable for the buildings of cultural heritage, will be analysed. Future work will focus on laboratory testing of wall drying process accelerated by heating source from wall tempering. The potentials for use of wall tempering as a non-destructive technique for temporary mitigation of capillary rise in case of progressive deterioration on valuable fresco painting will be investigated in future.
