Practical and Analytical Methods for Evaluating Deterioration in Brick Walls

Thorborg von Konow

1. Abstract

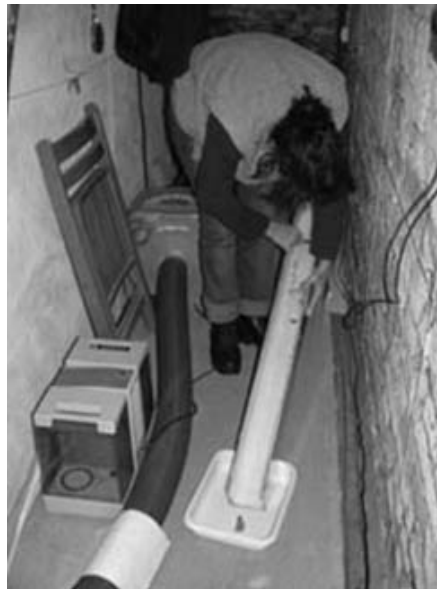
FIGURE 3. View from the TvF test room. Debris collected from receptacles.

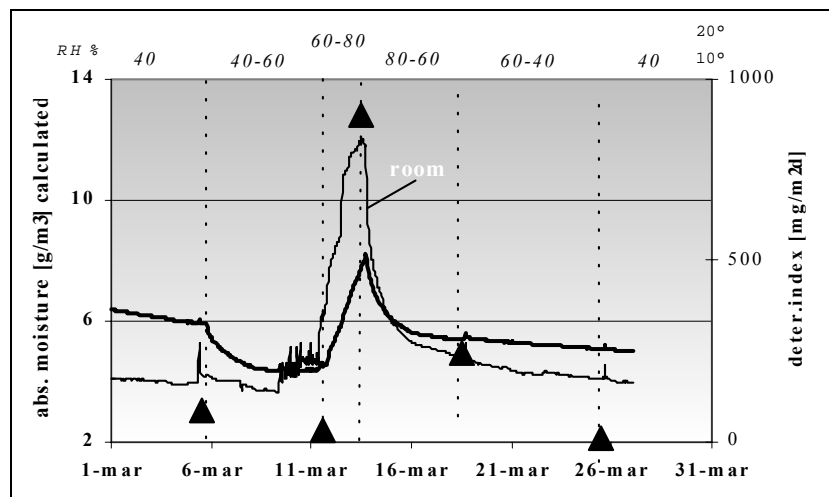
The changes in humidity are calculated in terms of absolute moisture [g/m^3] instead of RH to give a clear picture of moisture changes. The brick deterioration as collected debris before and after each period of the test is calculated as deter.index [$\text{mg}/\text{m}^2\text{d}$] and represented in the figures as dots.

FIGURE 4. Deterioration of one wall during changes in moisture in the test room during a 1-month test cycle. The deter.index reaches its maximum value during the period from 60-80% RH, when the moisture in the room rises above the moisture of the wall, represented by the thick line.

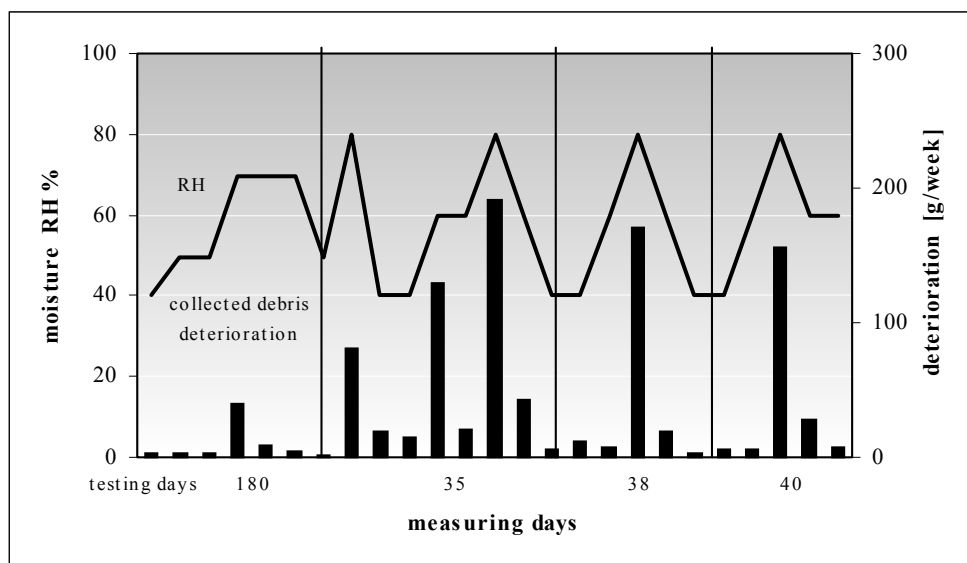
FIGURE 5. Results of four test cycles in the test room. The line denotes the relative humidity of the room. The columns show the collected debris from all the walls. The x-axis shows the length of the test period.

Figure 5 showing amounts of collected debris from the whole test room clearly demonstrates the validity of this method for monitoring the deterioration process during moistening and drying periods. In all of these test cycles the greatest deterioration appeared during the moistening period.
