# New Materials for Strengthening and Seismic Upgrading Interventions

Antonio Borri<sup>1</sup>, Marco Corradi<sup>1</sup>, Andrea Vignoli<sup>2</sup>

## 1. Abstract

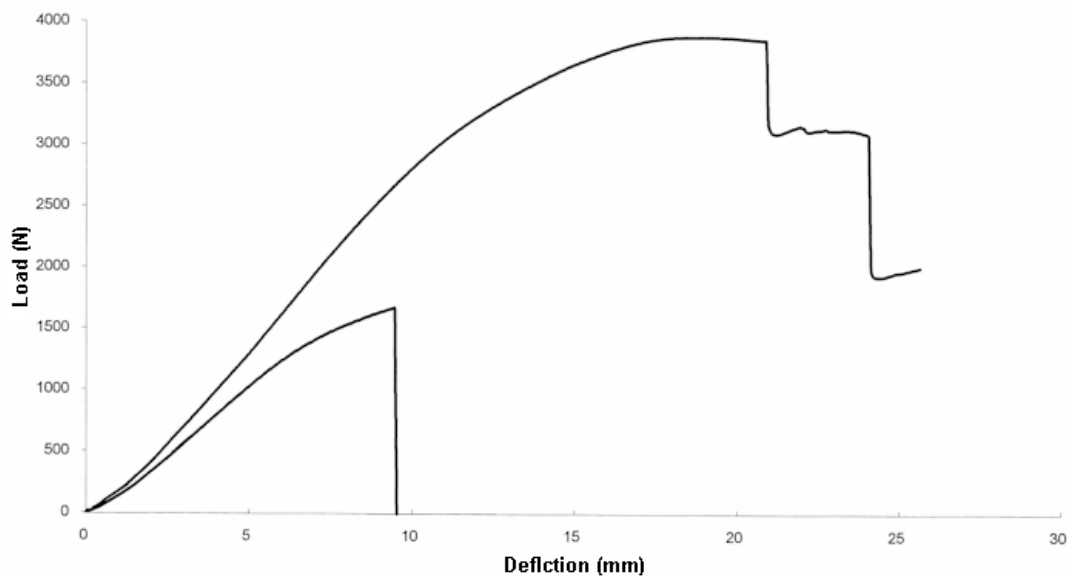
In Figure 3 the behaviors of the load-deflection curves of two different samples are reported: the sample was not reinforced while the second was reinforced with carbon fibers. As one can see, the two curves are both at the beginning near the linear behavior. In the case of not reinforced sample, the curve remains in the elastic field and not yielding point is evident up to the failure point. In the case of the reinforced sample, on the other hand, the yielding point is evident: after this point the slope of the curve is decreasing because of wood plastic deformation. When the composite reaches its crisis point, the sample fails in the zone loaded in tension.

FIGURE 3: Typical bending behavior of a un-reinforced and a reinforced sample

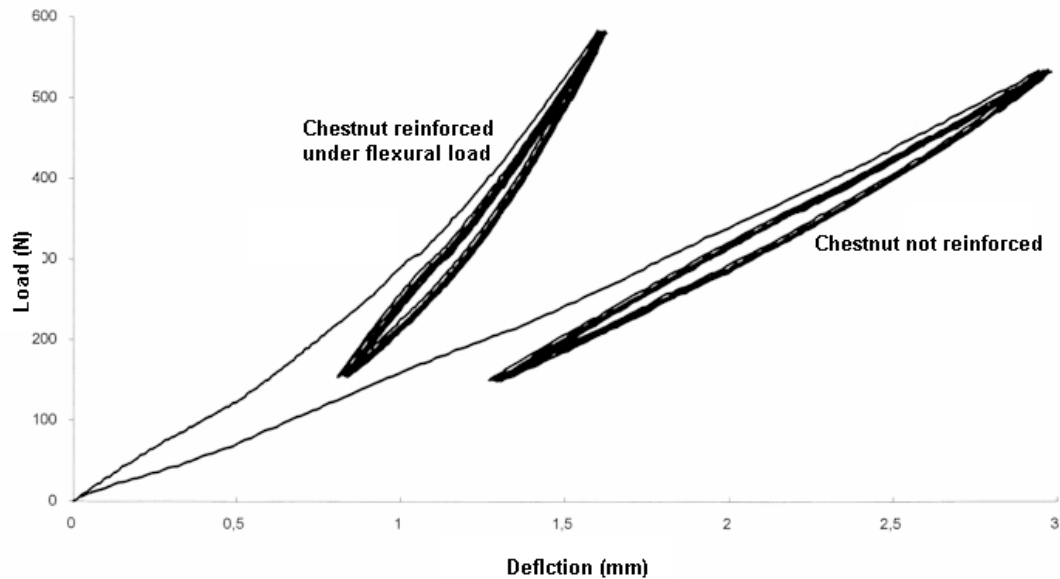
Regarding the stiffness increase because of the reinforcement, it can be noted that it has in general been not very high. As showed in Figure 4, it is possible to obtain an increasing of the stiffness of the samples, simply pre-loading them. The curve represented in Figure 4, in fact, shows the bending behavior of a not reinforced sample, together with the behavior of a sample made gluing the composite reinforcement when the wood sample was under flexural load applied in the direction opposite to the test one (the flexural load was equal to 0.25 times the ultimate load of the not reinforced sample). As one can see, in the second case the increase of the stiffness has been equal to 80%, while in the first one it has only been equal to 28% (see Table 6, Chestnut wood, for CFRP and GFRP fibers). All this without affecting the sample's strength. But more tests should be necessary in order to better qualify such type of behavior.

*FIGURE 4: Bending behavior of a not reinforced sample and of a sample made gluing the composite reinforcement when the wood was under flexural load*

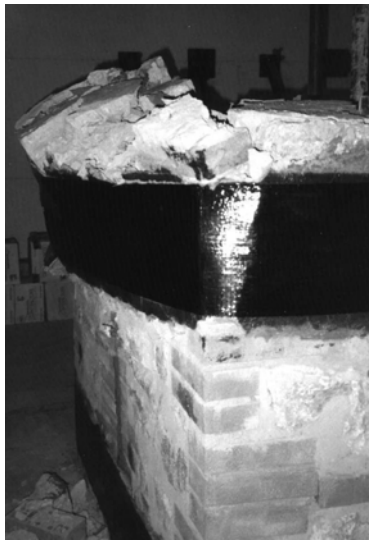
FIGURE 5: The containing action of FRP sheet

The solid brick and the stone masonry cells failed respectively at a load of 70 kN and of 90 kN. The low flexural stiffness of the CFRP sheet caused large lateral deformations at the maximum load. The experiment showed that the FRP reinforcement maintains its effectiveness until the crushing strain of masonry is attained. A significant consequence of the presence of the FRP reinforcement was the absence of the out-of-plane collapse of the masonry wall. The FRP sheet was in fact able to contain the stones and bricks resulting from the crumbling of the masonry wall (see Fig. 5).

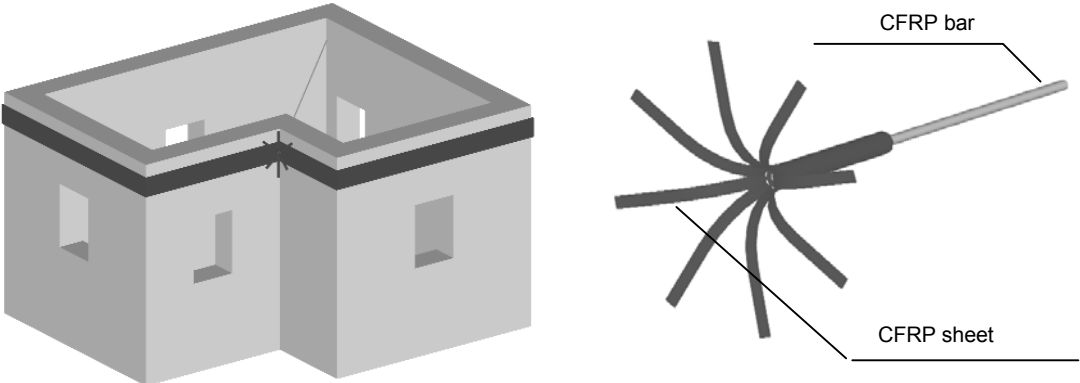
FIGURES 8-9: A proposed solution to the problem of non-rectangular buildings. Research is in progress in order to connect different FRP materials used for seismic upgrading of masonry structures

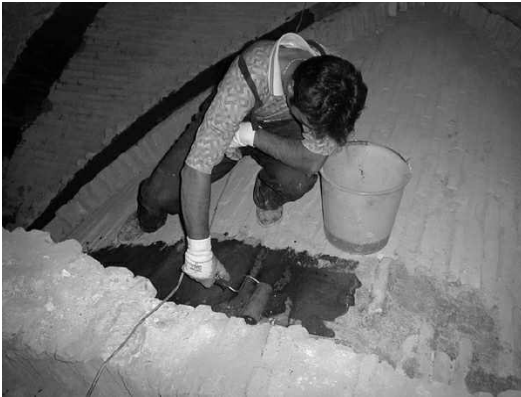
FIGURE 18: Primer application

After having thoroughly cleaned (by sanding and water cleaning) and then leveled the surface of the outer vault area, 4 bedding bands were created using suitable mortar. After the few days required for curing of the mortar, the surface was prepared with a suitable primer and the first monodirectional layer of FRP was laid with epoxy-resin. A second layer was also prepared (see Figures 18-19).

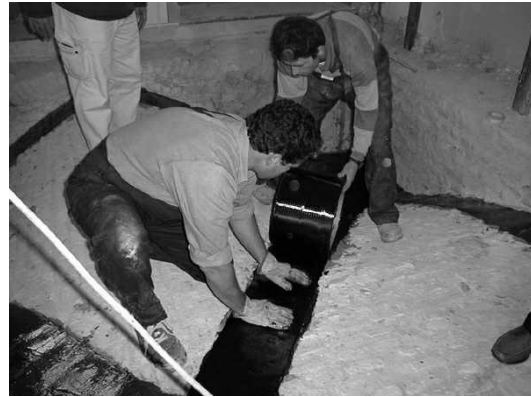
FIGURE 19: The fixing operation at the extrados of the vault
