# **New Materials for Safeguarding Cultural Heritage**

Mihai OPREANU

architect, senior lecturer, University of Architecture and Urbanism "ION MINCU", Department of Technical Sciences, Bucharest, Romania

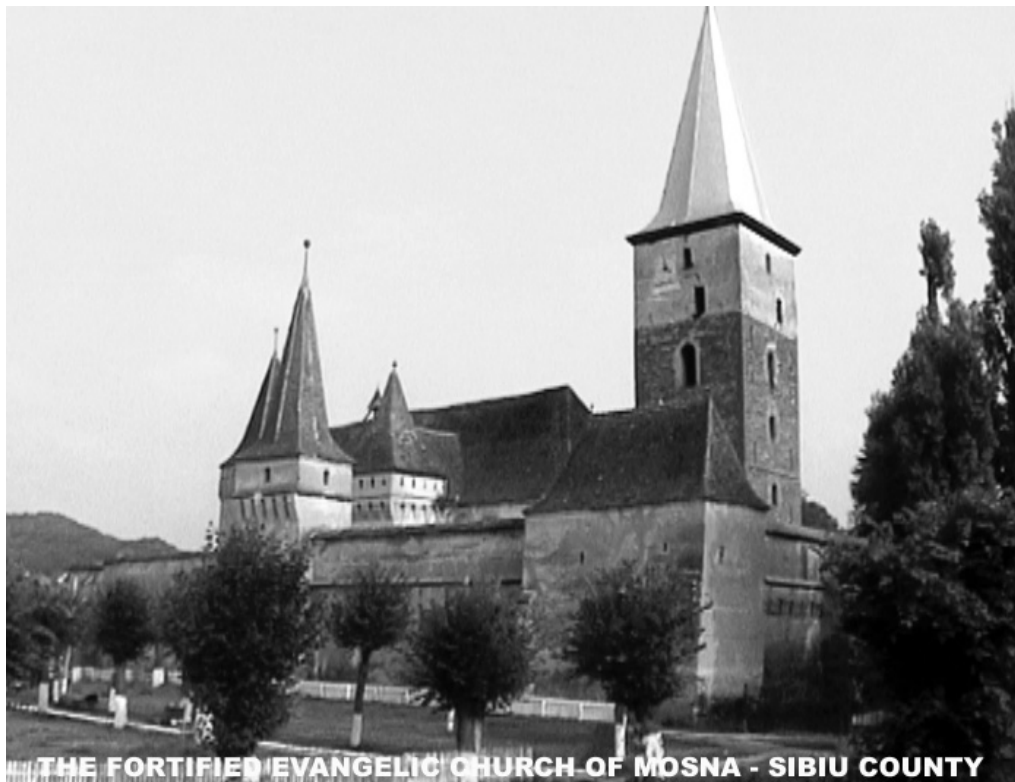
The monumental ensemble of the stronghold of Mosna belongs to a series of fortifications built by the peasant communities of Saxon colonization in Transylvania. Together with the stronghold of Biertan – Birtaelm, some 15 km away, it is one of the largest of the series. The major element of these ensembles is the church, dating from 1485, which is a fortification in itself.

The stronghold consists of a complex fortified precinct, with towers and different buildings, and the ruin of a Romanesque chapel.
