# New Materials and Safeguarding of Cultural Heritage

### ***“Sassi di Matera” DIPARC Project***

### ***Esztergom STUDIOLO Project:***

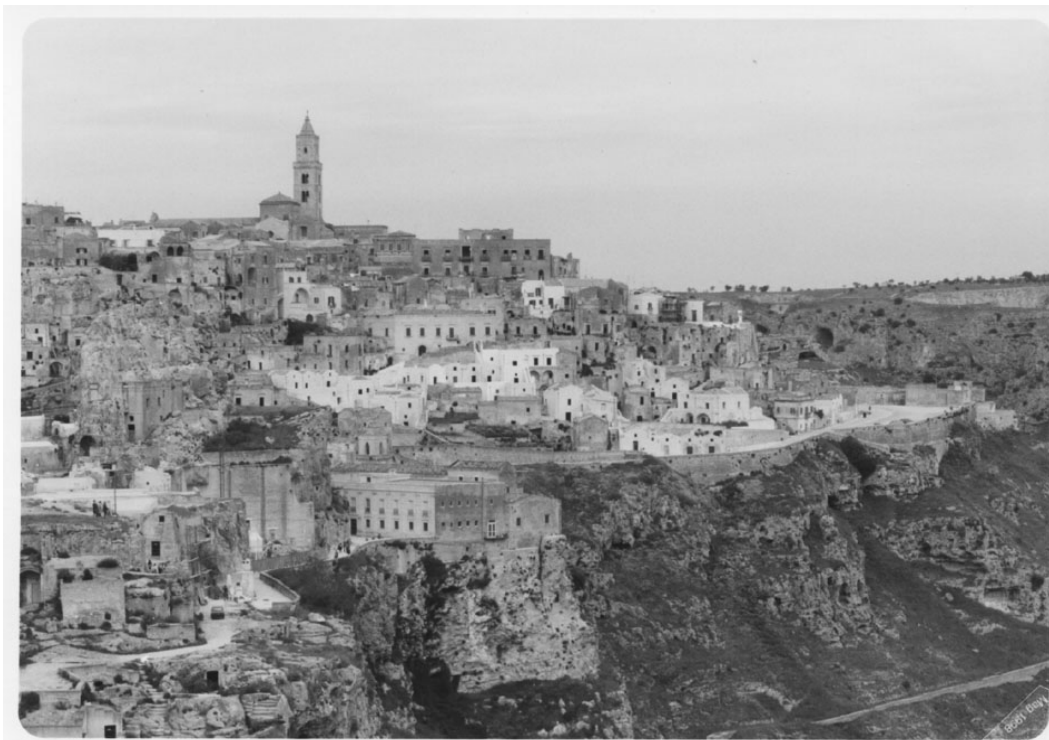
- Problems:
  - degradation of limestone
  - environmental deterioration

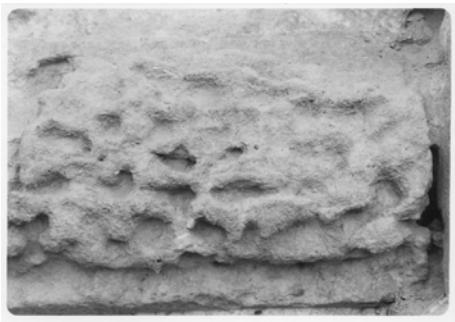
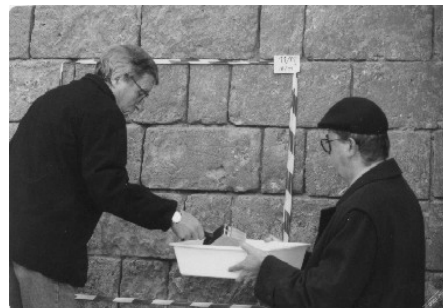
- Civita Rupestre -  
Rock-hewn Habitations
- Convicinio di San Agostino -  
Rock-hewn Churches, Case Study with ICCROM
- Santa Lucia alle Malve  
Rock-hewn Church with frescoes
  - biological degradation
  - humidity, porosity,

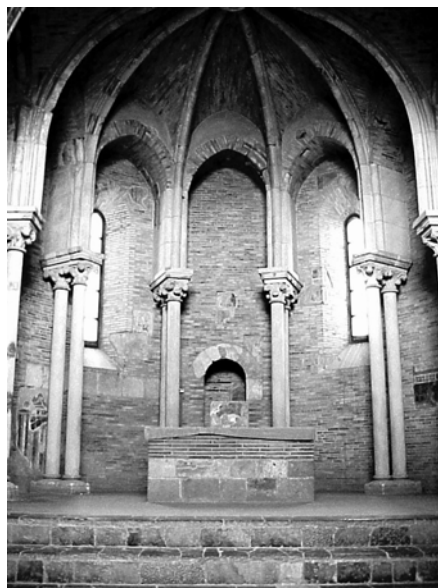
- History of monument  
Excavation  
1935
- History of the restoration, 1938 M. Pelliccioli.

The chapel was built by King Bela III.(1172-1196) and the oldest wall-paintings date back to this age. The second layer of frescos was painted at the start of the reign of the Angevins. The work of restoration is rendered more difficult by the fact that the frescos and remnants have been undergoing numerous debatable interventions. The purpose of the research is the discovery of the original layer.

- Degradations due to Materials of former restorations  
Materials of former restorations
  - 1938 , cement ,casein
  - 1968, „vinilic” mortars, Paraloid, artificial materials

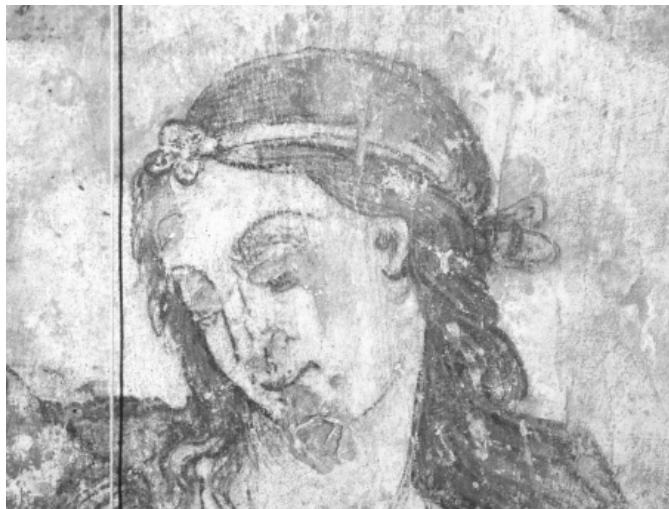
- Problems of current restoration
  - second detachment in the chapel after Pelliccioli.
  - Removal of all former materials, cement, vinilic fillings and borders
  - to take off the Paraloid from the wall, and other material applied in previous treatments
  - a fundemantal respect for the original painting
  - to use only natural products for fillings, borders and consolidation, to matching of the characteristic of the original painting.

Lime mortars mixed with different kind of pozzolana, lime-putty, acquarell.
