State of Art of Technologies for Safeguarding Historic Structures in Bulgaria

1. ABSTRACT

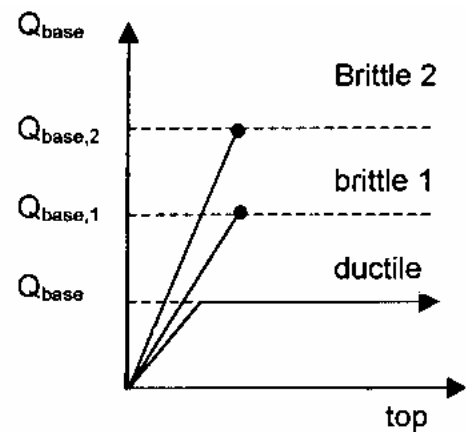
Fig. 2. Base shear - top displacement relationship for ductile and brittle structures subjected to lateral monotonically increased static load

Figure 2 illustrates the principle of strengthening that is used as basic philosophy. A single wall structure is considered being subjected to monotonically increased lateral load. This type of analysis is often used to predict some of the properties of the system.

The relationship base shear Q_{base} – top displacement, v_{top} , is selected as representative for structural behavior. Current design philosophy enables the structure to dissipate energy by making it ductile (see the plot of the line denoted by "ductile"). The elastic limit is slightly exceeded and inelastic behavior is initiated.

The plot of the next two curves in Fig. 2 is given for better understanding the difference that exists between ductile and brittle structures. The line denoted by "brittle 1" is representative for structure, whose capacity in shear is $Q_{base,1}$. Before reaching this limit structure will remain elastic. For a value of $Q_{base,2}$ slightly greater than $Q_{base,1}$ structure will be fractured. If this structure is to be improved, its strength should be increased rather its stiffness (see the curve, denoted by "brittle 2"). It means that the strength is increased reaching the value $Q_{base,2}$. The idea of strengthening is to increase structure strength using structural engineering approaches.

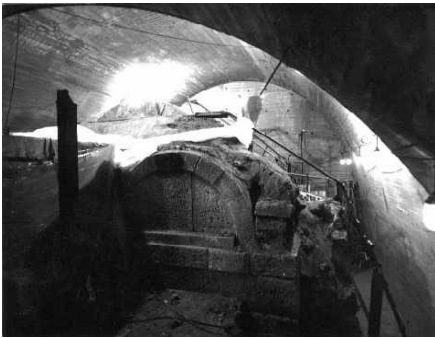
Fig. 18. Thracian tomb

This tomb (Figs. 18-20) was built in 4th-3rd century B. C. for a Thracian eminent ruler [2]. It is situated at an archeological reserve "Sborianovo" which comprises the territory of one of the most

remarkable centers of the religious and political life in ancient Thrace. The tomb illustrates the perfect construction technology, impressiveness, rich sculptor and painting decoration, high creation and talent of the genius ancient master. Therefore the tomb is included in the list of the world cultural heritage. It was discovered in 1982 excavating a tumulus. The tomb consists of a corridor (4,06 m long, 1,85 m wide and 2,15 m high) and 3 almost square cameras of different heights (4,55 m of the tomb camera and 3,25 m of the side camera). They were built by well trimmed stone blocks from white limestone and they were covered by semi-cylindrical vaults. The total dimensions of the tomb are 7,52 m long and 6,23 m wide at the facade. This unique monument of exclusive significance is a part of an unified architectural complex.

The structural and technological preservation, restoration and presentation of the tomb was a complex problem due to the following severe limitations: prohibition to the wet processes near the tomb, to keep the climatic conditions in the tomb, highest biological sterility of the used materials, maximal consideration and utilization of the soil properties (collapsible loess of second group), minimal risk, etc. Two temporary protection metal covering were mounted (Figs. 18, 19, 21) [17]. First one was also climatic and nearest to the tomb. It was assembled by the steel sheets simultaneously with the careful excavation around the tomb. A soil layer 60-70 cm thick was remained on the tomb to keep the internal climate. The second one was erected later on the tumulus part above the tomb and it was a tubular scaffold of large dimensions (about 18 m span) and far from the tomb.

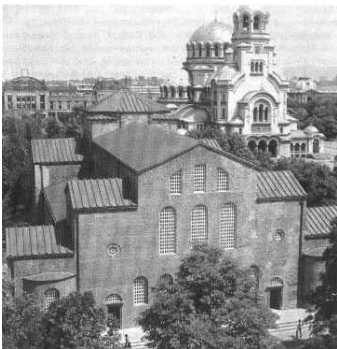
Fig. 22. St. Sofia basilika

This church is a unique monument from the early Byzantine construction. It dates from the second half of the 5th century [1], [2], [3]. It is a three auditorium construction with total length 46,50 m and width 23,00 m (Figs. 22, 23, 24). The central part of the structure is divided into three auditoriums by massive masonry columns with a cross-type cross-section. They are connected one another by arches without capitals. The main auditorium after crossing with the transverse auditorium continues with a same height in the altar space and forms a Latin cross. On the crossing place of the two auditorium a square is formed marked by 4 columns that sustains the main cupola by means of 4 triangular spherical surfaces. The cupola is hidden from outside by tetrahedron. In 1878 the main architect of Sofia the Czech L. Bayer and engineer Prosech pay attention to the church keeping and restoration.

1st combination - max stress = stress caused by the vertical load + stress from the seismic action; 2nd combination - min stress = stress caused by the vertical load - stress from the seismic action.

The characteristic stresses of the wall masonry are: compression stress is 0,9 MPa, tension stress is 0,03 MPa, tension stress under bending is 0,04 MPa, shear stress is 0,05 MPa but for the roof masonry they are 0,5 MPa, 0,005 MPa, 0,01 MPa, 0,01 MPa respectively. The vertical stresses σ_z and the tangential stresses in walls and columns caused by the vertical and seismic loads exceed the material strengths. As a result brick elements are in danger. The stress concentration around the tension members is observed. Full scale dynamic experiment is realized too [4]. The numerical and experimental results have good agreement.

Many structural damages are detected [13]. Large cracks in vaults, domes and walls, soil settlements, deformations, decrease of the material strengths by the surrounding environmental effects, etc. are available. The main reason for damages are the past strong earthquakes. Some structural interventions are made during the last years to safeguarding of this unique and important monument in the center of Sofia. The investigations discovered that the structure responses as it is comprised of particular (isolated) fragments due to the deep and large cracks between them and insufficient contacts between the interventions. The structural spatial unity is slightly expressed. The basilica was very vulnerable to seismic actions. Therefore the effective structural measures were accomplished to restore the entire response of all structure.

The cracks are filled up by injection of mix prepared by epoxide resin, stone powder and marble sand (Figs. 25, 26) [13]. A SIKA injection technology for restoration of the masonry continuity is applied. The large cracks are excavated 10 cm deep and enlarged to ease their injection. Some of cracks are filled up gravitationally discharging carefully the mix mortar from the roof after the cracks were preliminary closed by a thin surface coating. About 2 tones epoxide resin are used. Some masonry and masonry joints are rebuilt. The r/c floor plate and beams are strengthened. The new r/c vaults and domes with their supporting beams and rings are cast-in-situ on the old cracked brick masonry ones. The cracked masonry roof elements are hanged on the new ones by steel dowels (Fig. 26). The tension members of high strength steel bars are mounted in the arches and vaults. Their anchorage is in holes 50-60 cm in a diameter and 120 cm deep drilled in the walls or outside of the walls using the epoxide resin or cement mortar. They were tensioned by thread studs or nuts. Soil injection ate executed also. Some stone masonry foundations are enlarged and made deeper. Some temporary openings were blocked. An external r/c belt course is built at a level 0,00. Some tension members are assembled under the floor plate too.

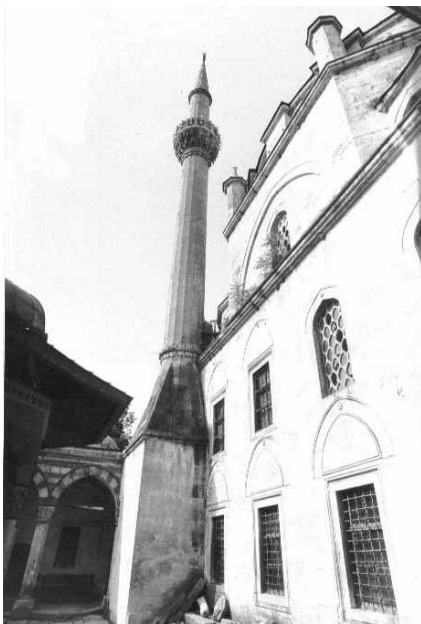
Fig. 29. Minaret in Shumen

The Tombul mosque (Figs. 29, 30) has been constructed in about 1743. The mosque minaret is 38,74 m high [21]. Till the +8,65 m level the minaret is joined to the mosque lower body but this connection is structural up to the +5,57 m level only. The minaret main high prismatic part has a circumcircle diameter of $1,70 \div 1,53$ m and wall thickness of $23,0 \div 18,5$ cm. The aboveground minaret structure up to the +30,55 m level is constructed by stone masonry. The principal damage of the minaret masonry is series of particular almost vertical cracks at the foot of the main prismatic part (Fig. 30 a). The cracked sector is $2 \div 3$ m high. It is need to check the minaret safety.

The full-scale dynamic tests of the minaret part between the $\pm 0,00$ m and +25,41 m levels have been done (Fig. 30) [24]. The masonry part of the minaret structure between the levels of +5,57 m and +30,55 m is studied numerically also (Fig. 30) [21]. It is modeled as a vertical plane cantilever beam-column rigidly fixed at its bottom to the minaret low body (Fig. 31). In order to consider all structural features the beam is divided into 20 finite elements. The linear dynamic, static and stability analyses of the model are accomplished by the FEM and ROKU program [22]. The well known uniform beam-column finite element of six DOF is used. The seismic loads, the dynamic and resonant wind loads are determined by the response spectrum method according to [7] and [25]. The structure static stability is verified and then the higher-order bending moments caused by the vertical loads on the deformed beam axis in small displacements are computed by the iterative Vianello-Dischinger's method. The cross-section bearing capacity is checked by the stresses.

A good agreement between experimental and numerical results is obtained. The structure safety is not ensured due to the horizontal loads. Therefore an urgent strengthening of the stone masonry is need to be made only from inside by an appropriate way to restore the minaret normal safety in accordance with the current Bulgarian design codes. The strengthening should cover in height the whole internal surface of the masonry wall or at least the unsafe lower portion of the main prismatic part. Two alternative ways for repair and strengthening are discussed in [21], [23]: prestressing by internal vertical tendons and construction of an additional internal reinforced concrete skin. The first seems to be a simple and elegant solution which would leave no visible traces. However it was considered as impractical because the masonry cross-sections will be too heavily loaded to withstand the additional compression from the necessary prestressing force of about 1000 kN. Nevertheless the first way was adopted but it was not been applied due to financial shortage. Moreover several cracked stones can be replaced by new hard ones.
