## Use of Steel in Refurbishment as an Environmentally Friendly Activity

### 1. Dismounting, transportation and rebuilding of a highway bridge

In 1988 the Hungarian Highway Authorities decided that instead of the full reconstruction of the deck plate of a 2 x 106 m span riveted truss highway bridge built in 1942 across the Tisza river at Polgár, a new bridge had to be built, just beside the old one.

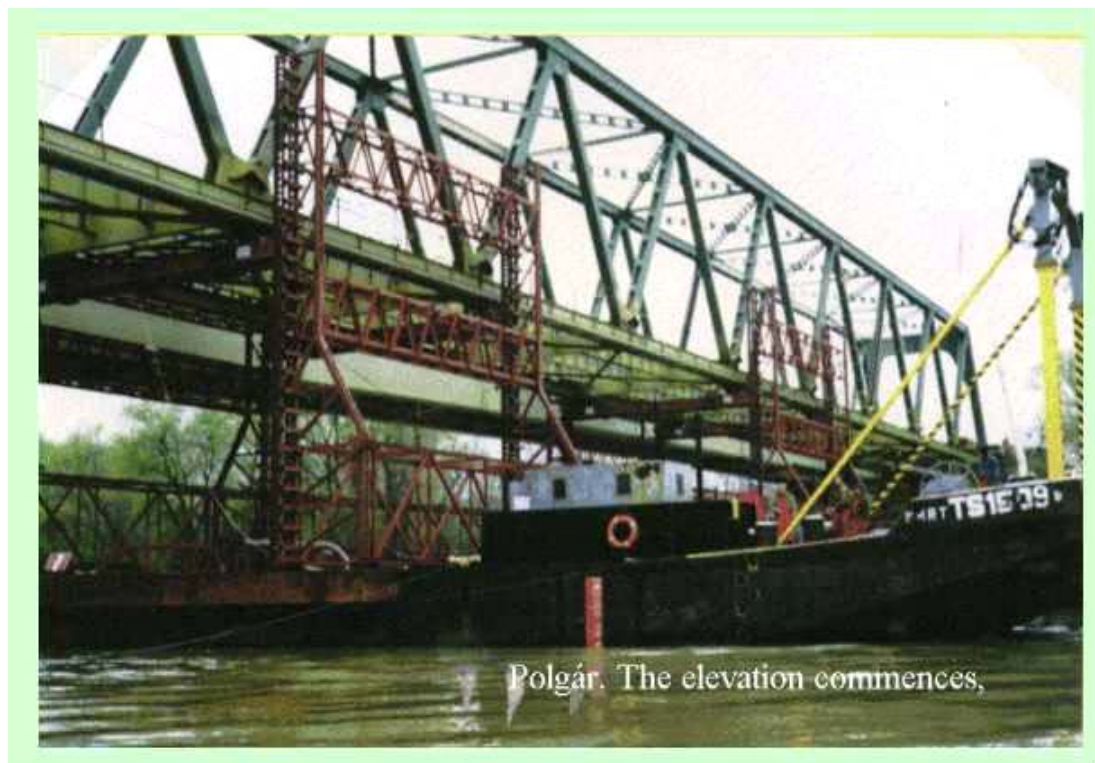
The new wider and higher load capacity bridge was opened to traffic in 1990 and the old one was closed, waiting for demolition. However, due to the good condition of the steel structure the idea arose to dismount the structure and rebuild it above the same river upstream in 100 km in a place where the modest traffic requirements had already been satisfied by a floating bridge.
