The Concept of Acceptable Technology in Architectural Conservation

Fernando M. A. Henriques, PhD

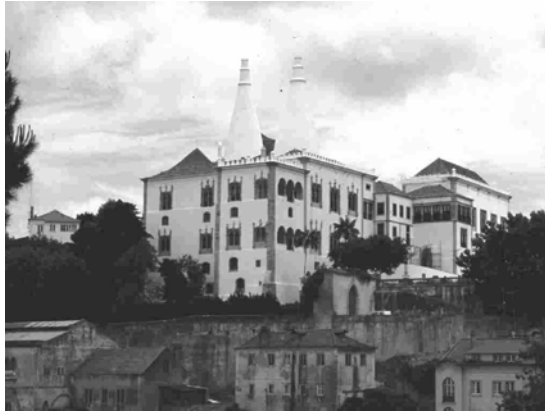
The National Palace of Sintra, located some 30 km to the West of Lisbon, is a historic building whose first references appear in 1281. The building is characterised by extensive rendered walls, with stone and mortar simulating stone pilasters in the angles. The most characteristic aspect of the building are the two large conical chimneys, that constitute the landmark for the palace (fig. 1). The damp climate of Sintra creates excellent conditions for biological development, resulting in the existence of extensive grey areas produced by vast biological colonization on most facades, creating a negative visual impact. For that reason an intervention aimed at replacing all the existing renders by new cement based mortars, considered more durable and efficient, was developed in 1995.

Fig. 1 – The National Palace of Sintra

At a time the work was to start, it was possible by the above referred methodology, to develop an entirely different approach based on the use of traditional technologies². Based on philosophical principles and on the fact that the existing renders were in very good condition, there are several layers of superimposed mortars applied throughout the centuries, a simple operation of removal of the biological colonisation by brushing and the application of a fungicide was envisaged, thus allowing to achieve the main objective: the conservation of the existing materials and the removal of the poor aspect of the building. For all the areas requiring the application of new mortars a mix of 1.5 parts of pure lime to 3 parts of pit sand and 1 part of river sand showed a very satisfactory performance in terms of adhesion, strength, dimensional stability and absence of significant cracking.

The solutions for surface finishes were basically two: a “marmorino”, a fine layer of lime putty and marble powder mortar (1:2) serving to give the final colour of the surface and a limewash, intended to correct any minor cracking that could occur. These solutions were applied together, except for some areas where the existing final coating was in such good condition in which the limewash was applied for aesthetic reasons.

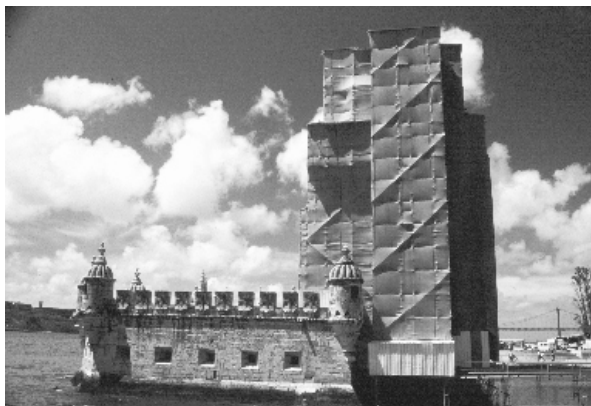
Some years before, in 1993, the intervention on the exterior of the Tower of Belém had been started. The Tower (fig. 2), a landmark of the discoveries period, is included in the World Heritage List of UNESCO. This intervention, lead by the association World Monuments Fund (Portugal), faced the need for the treatment of a considerable amount of joints with missing mortars (totalizing some 8000 linear metres).

The tower is located by the river Tagus, in the city of Lisbon, surrounded by water and very exposed to environmental conditions. The project began in 1993, but was interrupted the following year and not resumed till 1997³. This large interval of time allowed the evaluation of the mortar applications that were used in an experimental area during the first intervention period. Given the very harsh environmental conditions that the building faces, such as the presence of considerable

Fig. 2 – The Belem tower

For this purpose special Italian binders LEDAN C30 and MTX were used, the latter for internal injections and the former for more surface finish, i.e. pointing (since it has much better behaviour). The mortars were prepared with mono-granulated sands, adequately chosen and mixed, resulting in very good mechanical behaviour and salt resistance. Although the compressive resistance of C30 was too high, the formulations were worked in order to decrease significantly their values to a more satisfactory level. Furthermore, the very hard limestone used in the monument allowed the application of such a product. Although the exact formulation of these binders are not known, X-Ray powder diffraction analysis allowed the identification of the following crystalline materials:

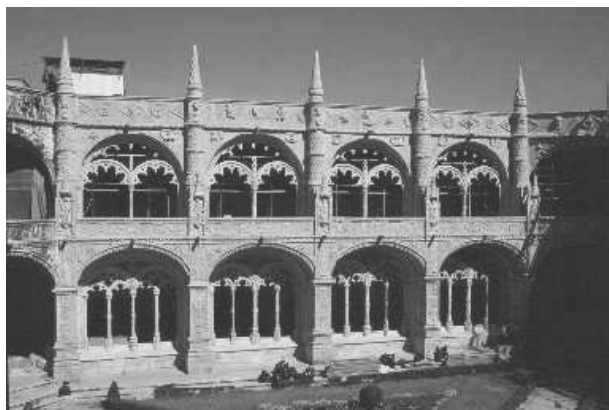
The very impressive behaviour of this type of mortar, particularly in what concerns adhesion, resistance to salts, water absorption and dimensional stability, lead to their use in the new project of the conservation of the cloister of Jeronimos monastery (close to the Tower of Belem), also included in UNESCO's World Heritage List (fig. 3). The work on this project began in 1999 and was completed by the beginning of 2002, given the considerable extension of the monument. In this case again, the extensive amount of joints requiring repointing, totalizing some 20.000 linear

metres, was one of the main problems. The same type of mortar was used although, since this building is considerably less exposed than the tower, most of the work was done with MTX (the weaker of the two binders), and C30 was used only in the very surface layer just as a measure of colour correction.

Fig. 3 – The cloister of Jeronimos monastery

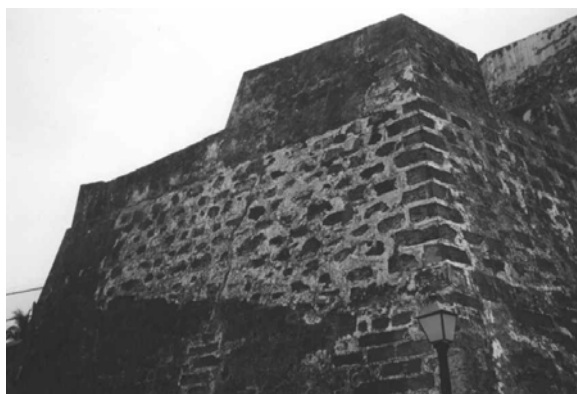
In mid-1999, US/ICOMOS invited five international experts to analyse the situation of the city walls and forts of San Juan, in Puerto Rico, included in the World Heritage List. The massive walls are made of stone masonry that was initially rendered (fig. 4). However, most of the renders were missing at the time, so the critical conservation issue raised by the Puerto Rico Historic Preservation Office and the National Park Service was the identification of appropriate technologies for conserving the walls. After a week of work on site, the experts⁵ decided that the best approach was to apply pure lime mortars, following formulations that had to be evaluated locally with the help of small experimental applications.

Fig. 4 – View of the walls of S. Juan, Puerto Rico
