New Technologies for Safeguarding cultural Heritage– A State of the Art of applied Research and Practice in Belgium

F. Van Rickstal¹, L. Schueremans¹, A. Beeldens¹, E. Toumbakari¹, S. Ignoul², K. Brosens², K. Van Balen¹, D. Van Gemert¹

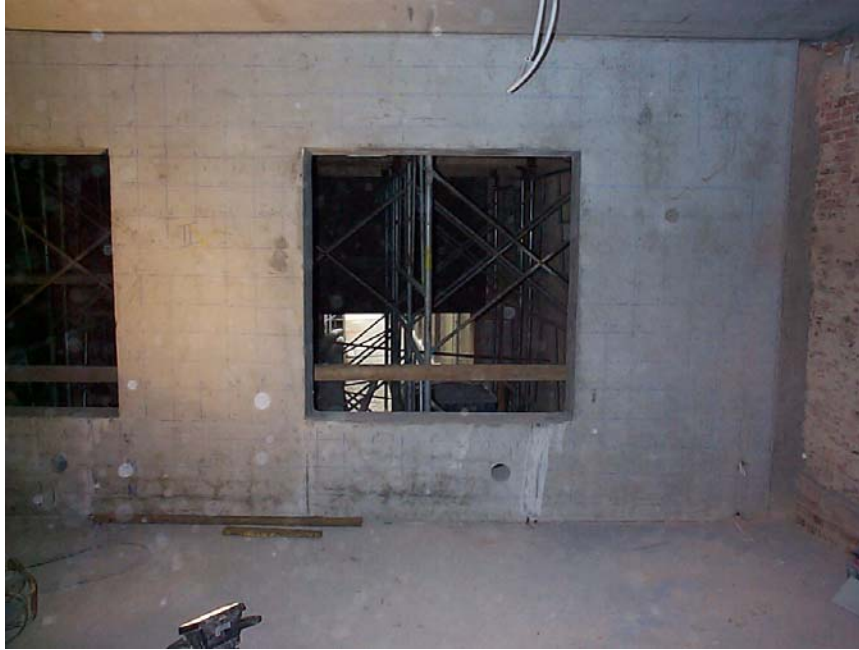
Fig. 1: The investigated wall consists of two prefabricated faces filled up with poured concrete. The raster shows the measuring points.

1 shows a wall that consists of two prefabricated concrete parts that are filled up with concrete. The responsible man on site had a suspicion that the filling up of the prefabricated wall was inadequately done and requested the Reyntjens laboratory to investigate the wall. Fig. 2 shows the transition time as measured on the wall. The light zones show a transition time of about 60 to 90 μsec . The darker the greyscale, the higher the transition time and the worse the filling of the zone between both faces. These zones are injected with epoxy resin to ensure perfect contact between the faces and the poured concrete.

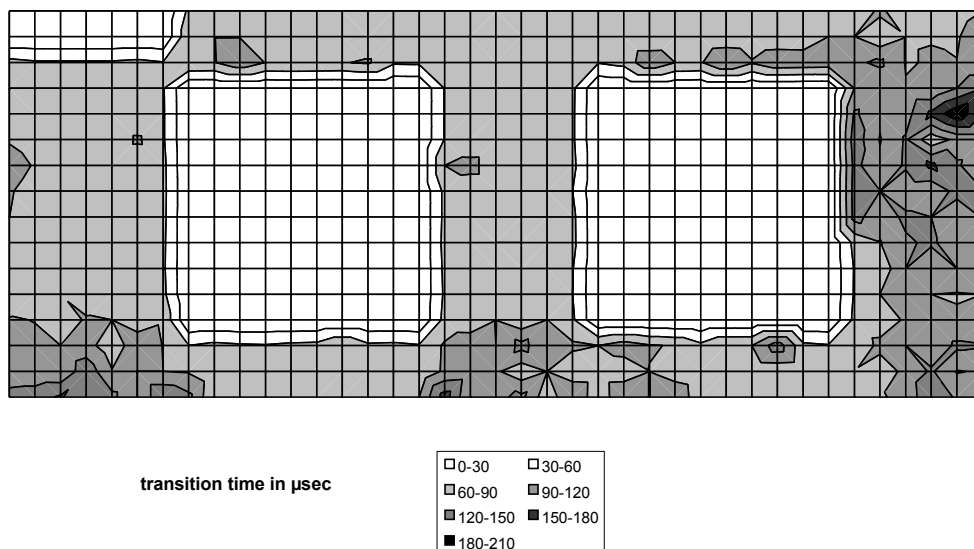
Fig. 2: The map of the transition time displays the zones that were inadequately filled up.

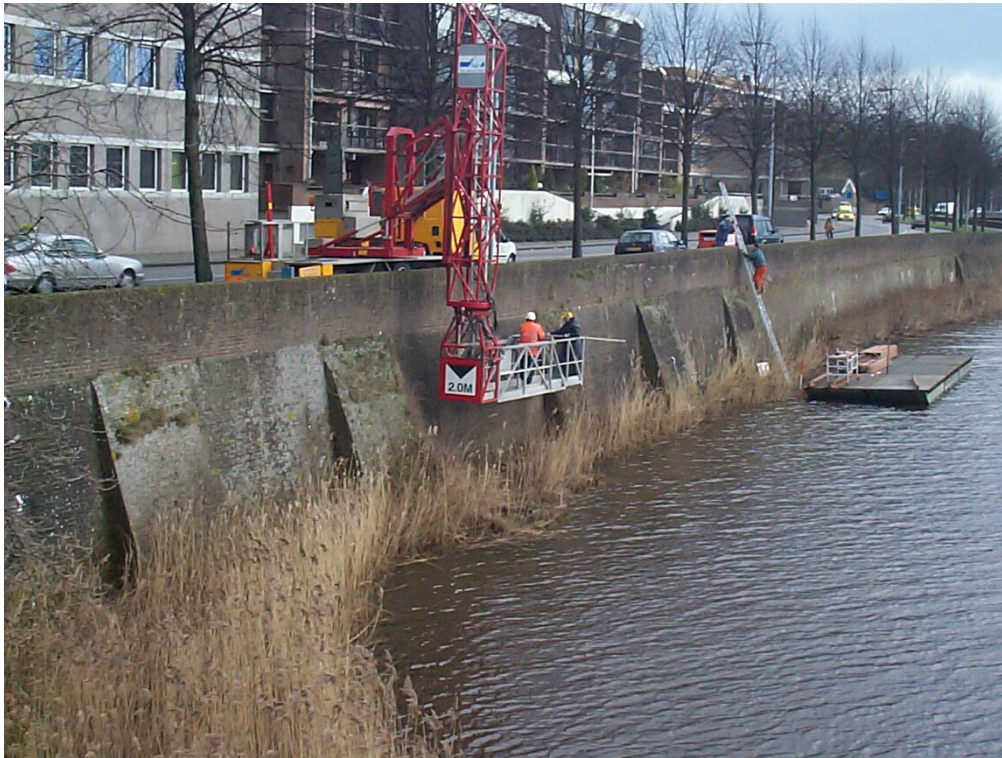
Fig. 11: The historic rampart of 's Hertogenbosch is geo-electrically measured.

A second large non-destructive study was carried out on the rampart of 's Hertogenbosch in Holland. The city side of the rampart is covered with soil and can not be examined. The Reyntjens laboratory was asked to scan a 300 m zone of the rampart using geo-electrical measurements in order to determine the weak zones of the wall. These zones get a thorough inspection, are cored more intensively and in necessary injected to consolidate them.

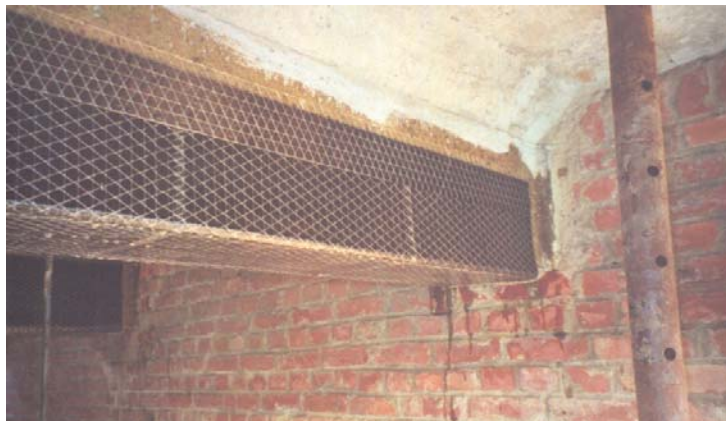
Fig. 13: External reinforcements using CFRP (Tienen (B))

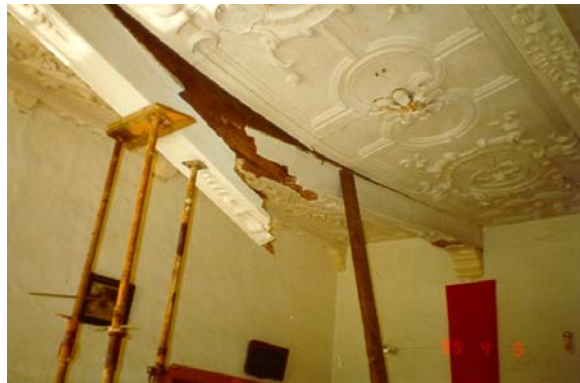
Fig. 14: The wooden beam broke due to overloading and deterioration

This creative application of reinforcement was applied at the castle of Horst. A wooden beam broke because of a mindless decision to pour concrete on the first floor without supporting the bearing structure, as shown in Fig. 14.

This was partly due to overloading, but the wooden beam was also thoroughly penetrated by the deathwatch beetle. The only possibility to save the valuable stucco consisted in removing the old timber as much as possible, and to replace it with epoxy mortar. At first the broken floor was lifted with hydraulic jacks to its original position. During the lifting operation the stucco was supported by strongly deflected thin glass fiber reinforced polyester rods. They could straighten during the lifting operation and thus provide a continuous support for all the loose stucco parts, preventing them from falling off, and keeping them in place for later fixing with epoxy adhesive.

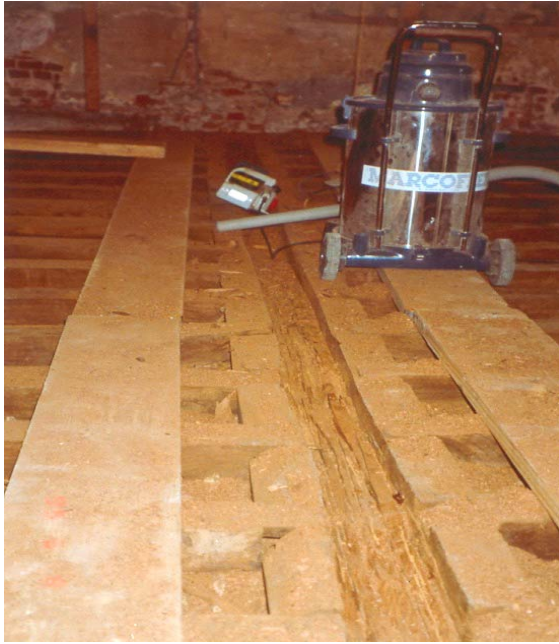
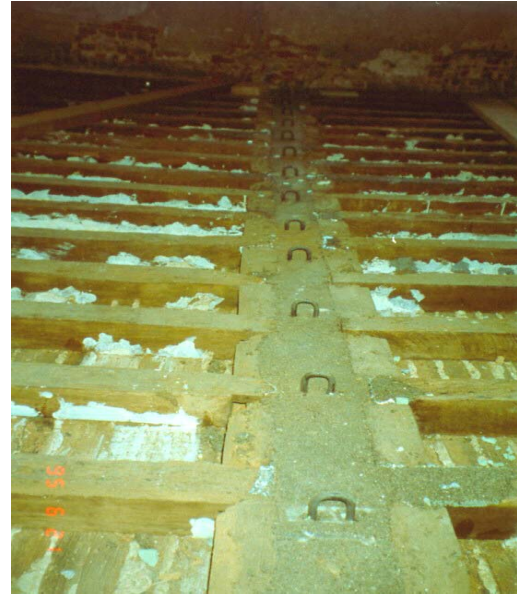
Fig. 15: A large groove is milled out of the wooden beam and reinforced with steel bars and filled with epoxy mortar

A large groove was sawed in the topside of the beam, as shown in Fig. 15. In this groove a strong steel reinforcement has been placed, and the groove has been refilled with epoxy mortar. At the topside some dowels are placed already now, to allow for a later strengthening of the beam by applying an additional layer of mortar. The dowels will then serve as shear connectors (Fig. 16). Fig. 15 also gives a view of the beam, filled with epoxy mortar and with the dowels standing out from the mortar. Fig. 18 shows the repaired beam and the saved strucco.
