Technologies for Safeguarding of Heritage Buildings in Slovenia

Dr. Roko Žarnić

Associate Professor, University of Ljubljana, Faculty of Civil and Geodetic Engineering (UL FGG),
Chair for Research in Materials and Structures, Jamova c. 2, 1000 Ljubljana, Slovenia
e-mail: rzarnic@fgg.uni-lj.si

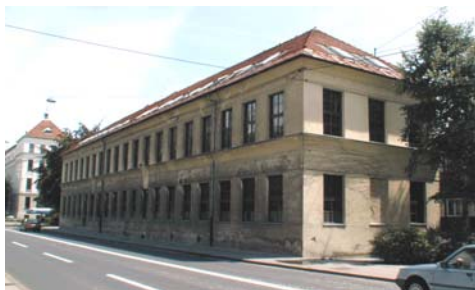
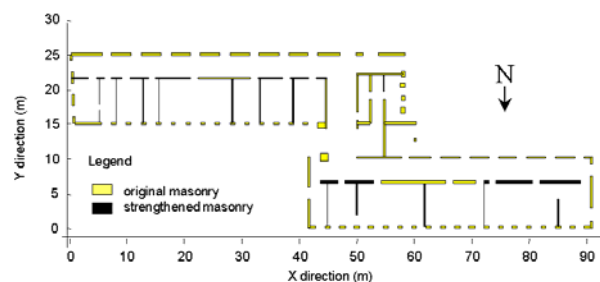
Figure 1: West-east view of building's northern part and layout of ground floor load bearing walls

The building is divided in two parts connected with entrance hall. The approximate length and width of the southern part's plan are 60 and 10.5m, respectively. The approximate length and width of the northern part's plan are 50 and 10.5m, respectively. The cellars are located only under the parts of the ground floor. The story heights of ground floor, first floor and attic are 4.3m, 4.1m and 4.5m, respectively. The original structural system of the building consists of clay-brick masonry walls and timber floors. The masonry walls are of the same width of 45cm in both ground and first floors. According to laboratory tests the compressive strength of bricks is in the range of 2.5MPa and estimated compressive strength of high quality lime mortar is about 1 MPa.

The layouts of the plan show relatively low shear resistance of stories (Figure 1) judging by contemporary demands. This was proved by the pushover inelastic analysis using the above-described program SREMB. The shear resistance of the masonry building depends mainly on the number and position of the masonry walls and their strength, stiffness and ductility. The main problem of masonry walls is relatively low ductility that can be improved by reinforcing the walls or by coating them. Vertical and horizontal reinforced concrete ties usually confine walls. In the case of the herein-presented building, the horizontal ties will be placed above the load-bearing walls during the replacement of existing floor structures with the reinforced concrete slabs. Altogether

The layout of the ground floor and the position of new and strengthened walls is shown in Figure 1. The cement plaster of coated walls is planned to be 3cm thick on each side and reinforced with steel mesh fabric of $3.35 \text{ cm}^2/\text{m}^2$. The new reinforced clay block masonry walls were assumed 25cm thick and reinforced with two steel rods of 6mm in diameter. The reinforced concrete shear walls of cross section dimensions 20/250-cm were assumed, made of concrete with compressive strength of 40MPa. They will be reinforced with steel mesh fabric of $3.35 \text{ cm}^2/\text{m}^2$ with boundary columns reinforced with $20\phi 12\text{mm}$ (steel $f_y=400\text{MPa}$). The easiest method of strengthening is applying coatings to the existing walls. In the case of the presented building, this method gives sufficient results in terms of both strength and ductility demands according to Eurocode 8 and the old Slovenian codes (Figure 3). If the building was located in an area with expected higher earthquake intensity, methods that are more radical would be necessary. Therefore, the results of seismic resistance analysis for the existing building and the building with coated walls are discussed, and briefly compared with the results of the analysis of the building strengthened with two other methods.

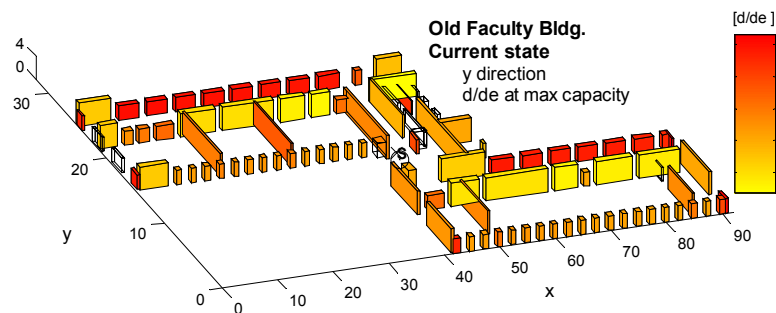
Figure 2: The distribution of deformation level of walls (building in current state)

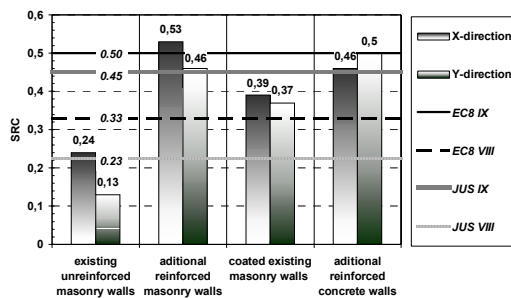
Figure 3: Comparison of base shear capacity of building strengthened with different methods

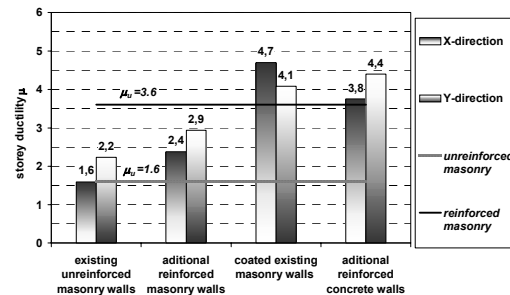
Figure 4: Comparison of base story ductility of building strengthened with different methods

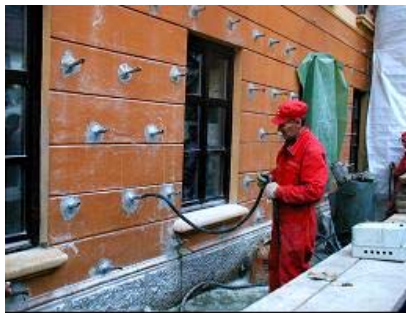
Figure 6: Grouting of stone masonry

The main purpose of grouting is to fill as much voids as possible. This makes stone masonry more homogenous and prevents movement of stone blocks and rubble during earthquake action. The needed strength of hardened grout is not too high because internal stresses induced in stone-to-grout interfacial surfaces are not high. That was proved by laboratory experimental research¹¹. Stone masonry walls grouted with four different grouts were tested by cyclic horizontal load and constant vertical load (Figure 7). Although the mechanical properties of grout expressed in terms of bending and compressive strengths (Figure 8), the shear strength and stiffness of grouted wall did not differ significantly (Figure 9). The composition of four types of grouts is presented in Table 2 below.

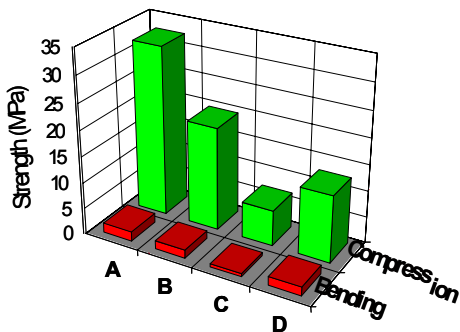
Figure 8: Compressive and bending strength of four types of grout material

Grout mix	Cement	Pozzolana	Water	Quartz dust	Additive
A	52,9%	5,9%	41,2%	0,0%	0,0%
B	50,0%	5,6%	38,9%	0,0%	5,6 (a)%
C	38,9%	5,6%	33,3%	16,7%	5,6 (a)%
D	38,9%	5,6%	33,3%	16,7%	5,6 (b)%

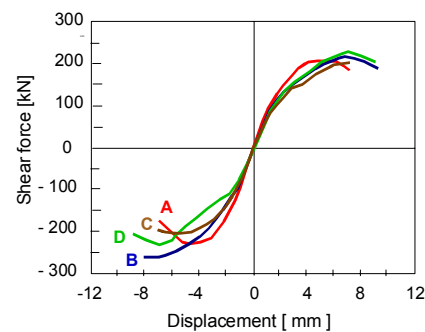
Figure 9: Shear strength - displacement relations obtained by cyclic testing of stone masonry walls grouted by four different grouts
