Restoration of Capella da Nossa Senhora do Monte Old Goa

Luis Soromenho Marreiros

1. ABSTRACT

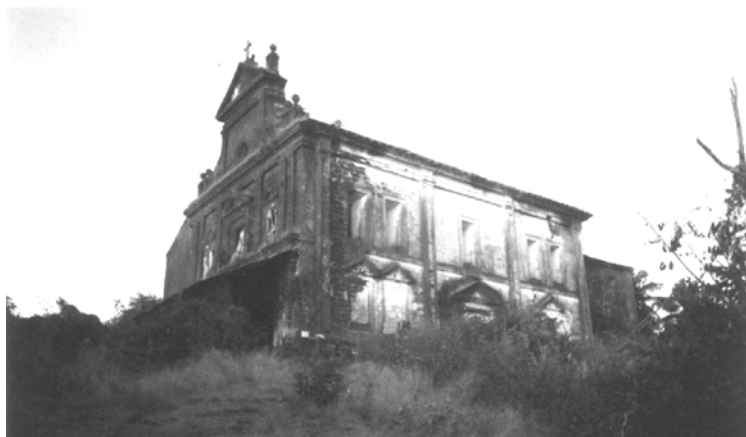
Capella Da Nossa Senhora do Monte is one of the first churches built by the Portuguese in Old Goa in the 16th Century. This Mannerist style chapel is perched on a small hillock overlooking the Mandovi River, and commands a spectacular view. The approach to the Church is by means of a series of laterite steps cut into the south side of the hillock as seen in Fig.1

Figure 1: View of the Capella De Monte from the South West.
