# Case Study of "Kristiania Kvadraturen" in Oslo

Jan F. Henriksen, Odd Anda and Thor Ofstad

## 1. Summary

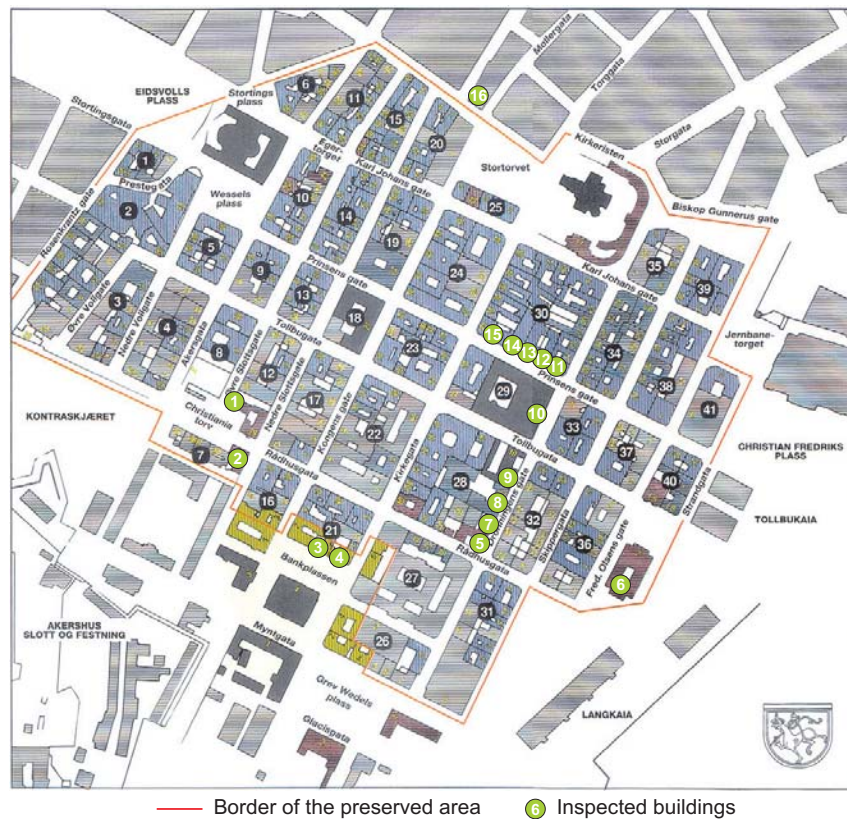
Figure 1: The preserve area “Kristiania Kvadraturen” with the inspected buildings marked. (Fortidsminneforeningen, 1996).

The area "Kvadraturen" and the selected buildings are shown in Figure 1. In total 16 buildings were inspected. 8 of the buildings were built between 1626 and 1800, the remaining were from 1800 to 1914.

The sources for the short history given for the buildings are two Norwegian books (Fortidsminneforeningen, 1996 and Bruun 1999), where a more complete description of the buildings and their history is given. The description given in the following chapters is following the numbering given in Figure 1.

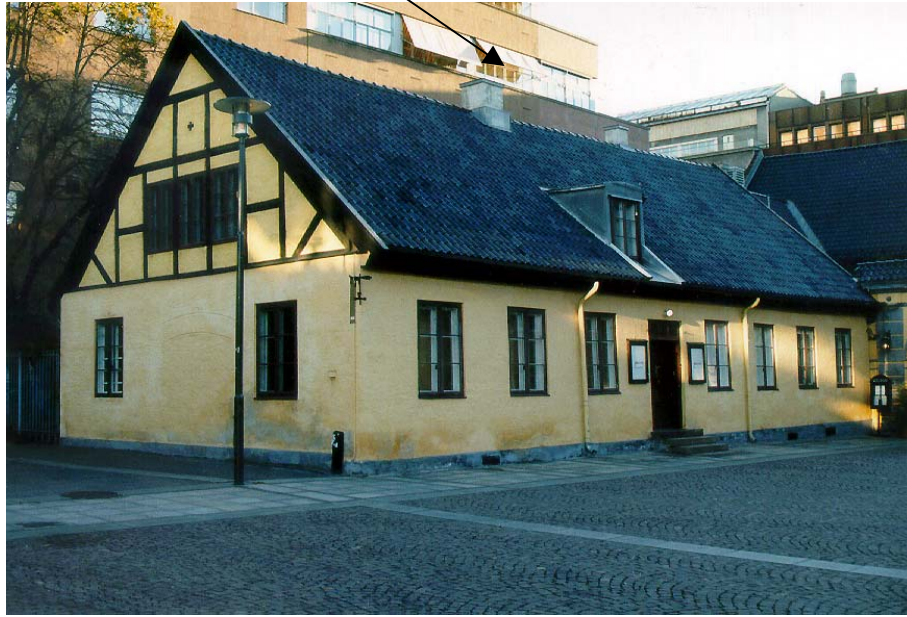
## 6.1 Rådhusgata 19, the annex

The building was built in the 1640-ies and is the oldest half-timbered house with calcareous rendering in Oslo. The house has one floor and an attic. It was originally a private home, but has had different owners and different use during the history. The house is to day used for exhibitions by Young Artist Society (UKD).

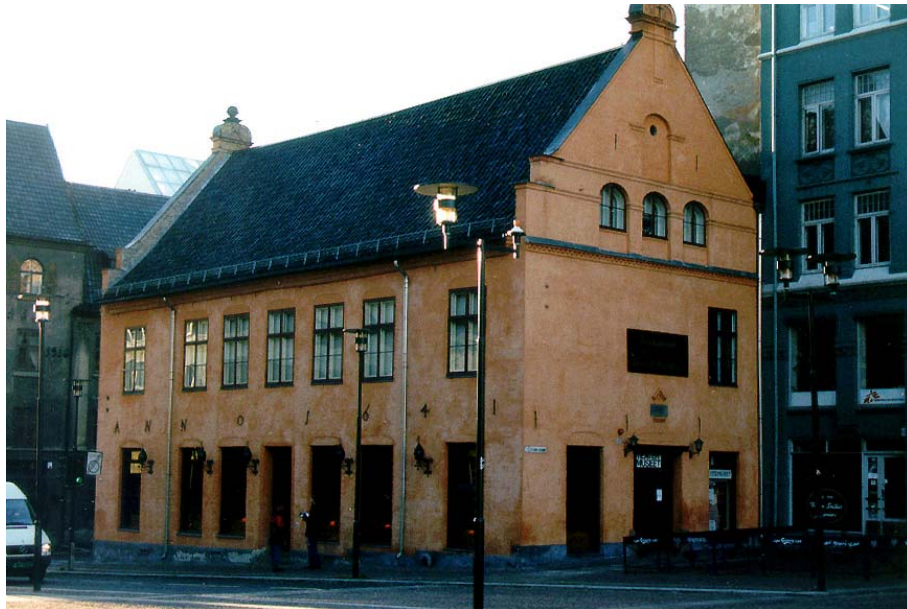
## 6.2 Nedre Slottsgate 1

The building was built in 1641 as the city hall of Christiania (Oslo), and was used as city hall up to 1733. A wing was attached in 1850-ies as a restaurant. The house has two floors and an attic. The building was partly destroyed by a fire in 1996 and has been restored to its

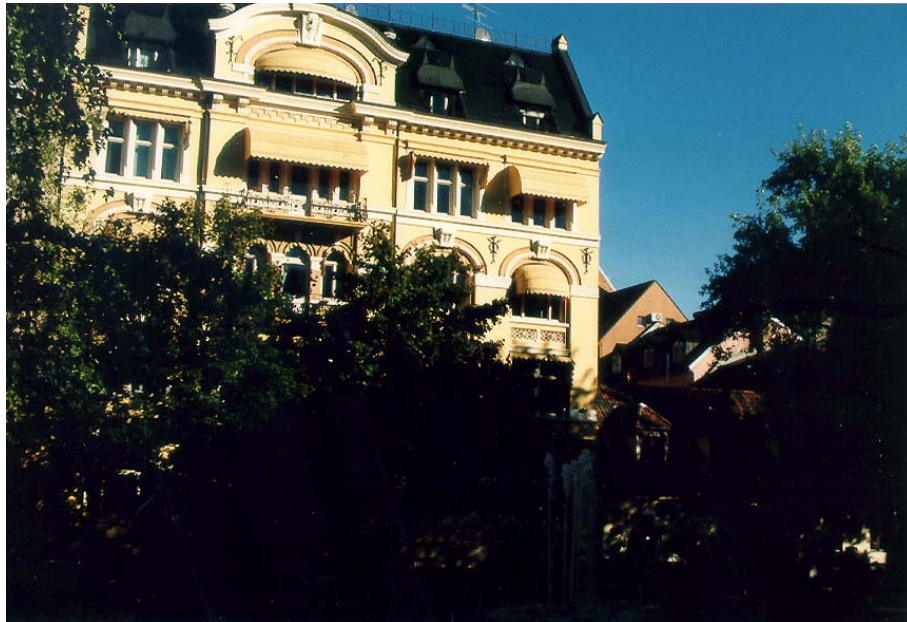
### 6.3 Banklassen 1A

The building was built in 1895 as an apartment house in new baroque style. The house has nice décor and mixture of materials used in the façade. The building is private owned and is used mostly as offices today.

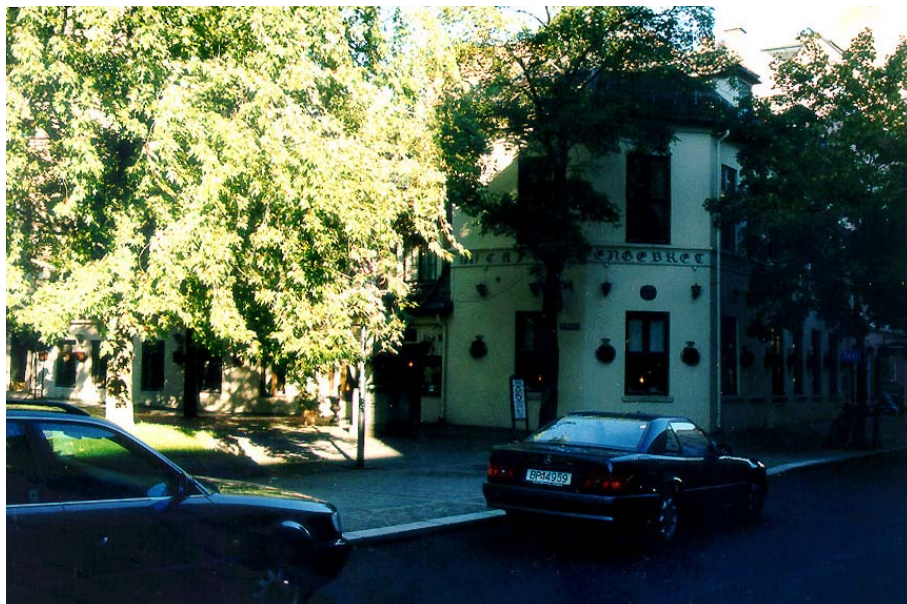
### 6.4 Banklassen 1B

The low part of the building is facing the square and was built in 1760 with one floor and an attic. The wing towards the street (Kirkegata) was built in 1814 with two floors and an attic. The building is private owned and contains the oldest existing restaurant in Oslo, Engebret Café from 1857. The building was restored in its old style after a fire in 1921.

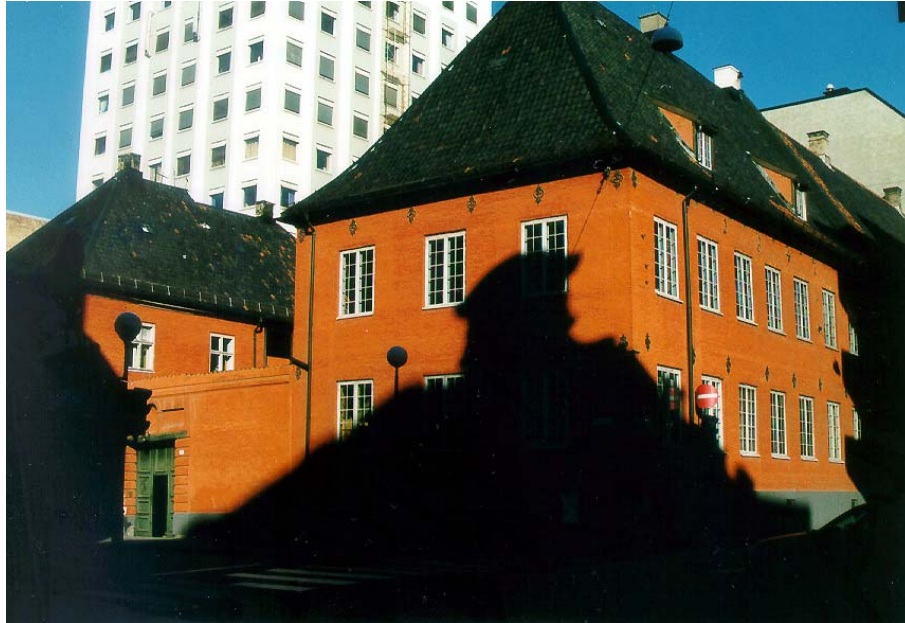
## 6.5 Rådhusgata 7

The building was originally built as a private home in 1647. The oldest part is facing Dronningens gate. The extension to Rådhusgata was built in 1750 when the building became the second city hall of Oslo. The building was the city hall from 1733-1843. It included the jail from 1745-1866 and became the police station from 1866-1963. The owner today is the City of Oslo.

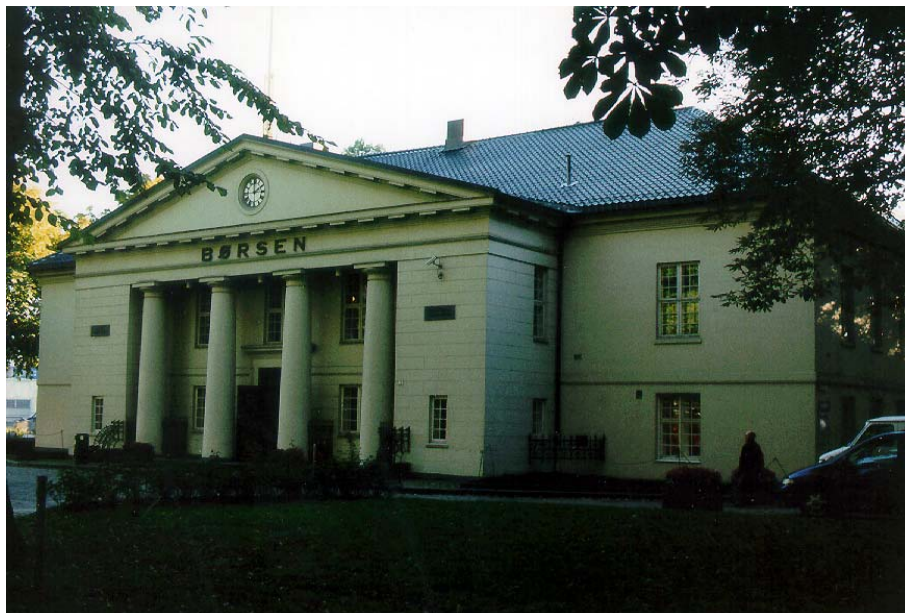
## 6.6 Tollbugata 2

The oldest part to the north was built in empire style as the stock exchange of Oslo in 1826-28. An extension in the same style was built in 1909-10. The building still contains the stock exchange of Oslo.

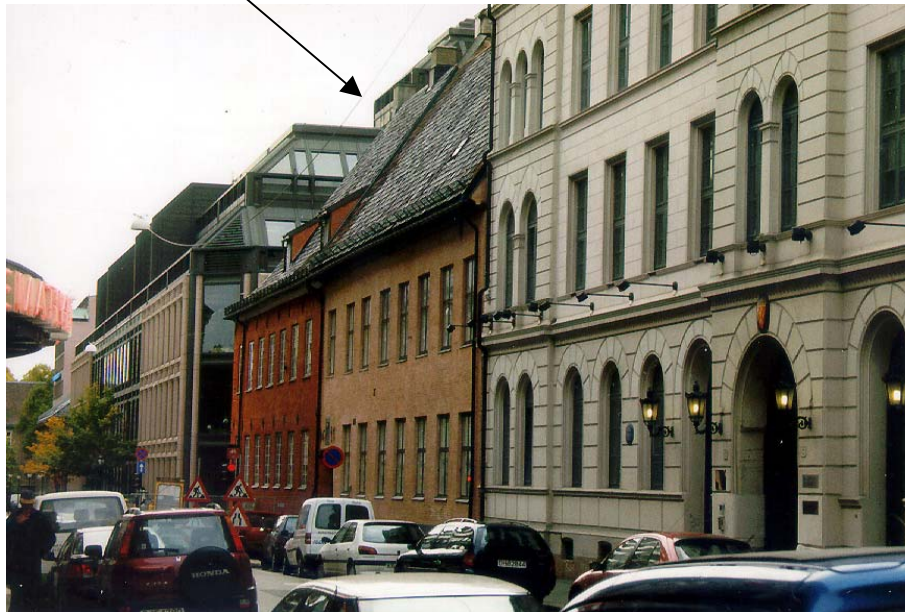
## 6.7 Dronningens gate 11

The building was built as a private home. The basement is from 1624 and the building was finished with two floors in 1647. It was private owned up to 1843, and a large private reconstruction took place in 1758. The building was bought by the City of Oslo in 1843 and was used as offices up to now. For a short period it contained the National Library of Norway

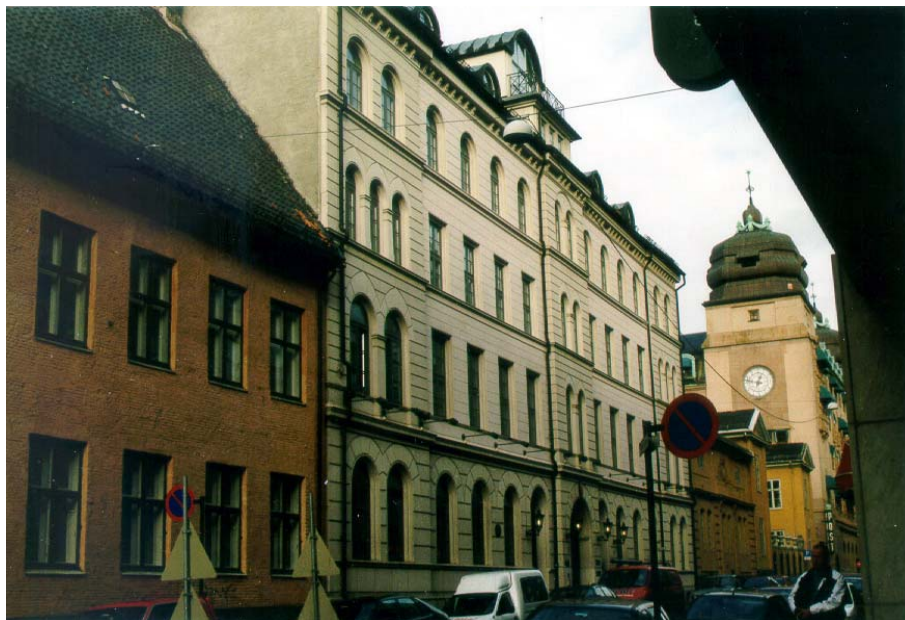
## 6.8 Dronningens gate 13/13A

The building has gone through a lot of re-constructions during the history. It was first built as a private home in 1643 and rebuilt in 1762. In 1828 it was again rebuilt and became Hotel du Nord. The hotel had a fire in 1859. The facade today is more or less the same as after the hotel was rebuilt in 1860. In 1899 the building was reconstructed to offices and one floor was added. The building is private owned and the user today is The Norwegian Directorate for Cultural Heritage.

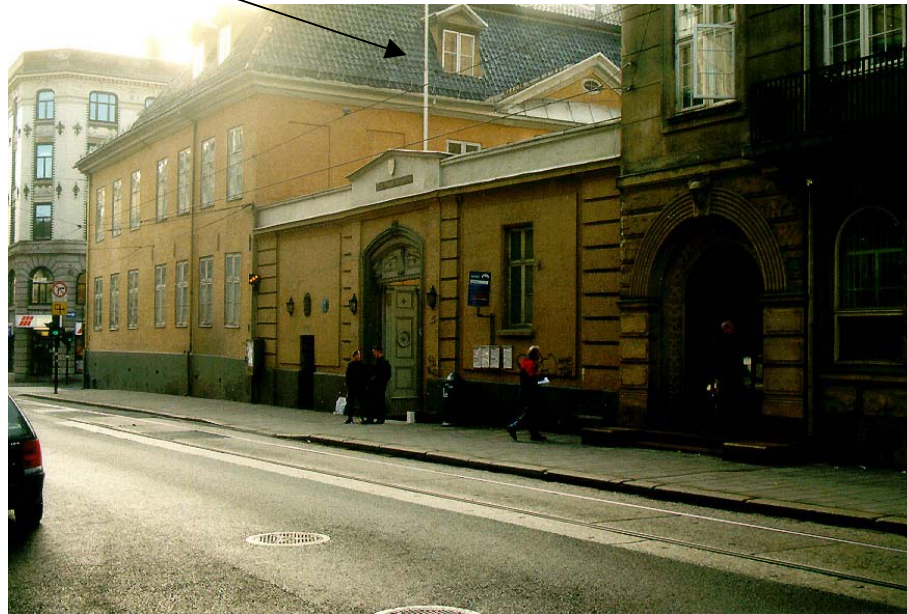
## 6.9 Tollbugata 10

The property has been used as private home from 1624 to 1802. The building, as it looks to day, is from 1765. From 1802 the building has belonged to the Norwegian Army, mainly as The Officers School. From 1979 it has been a representation house for the Army.

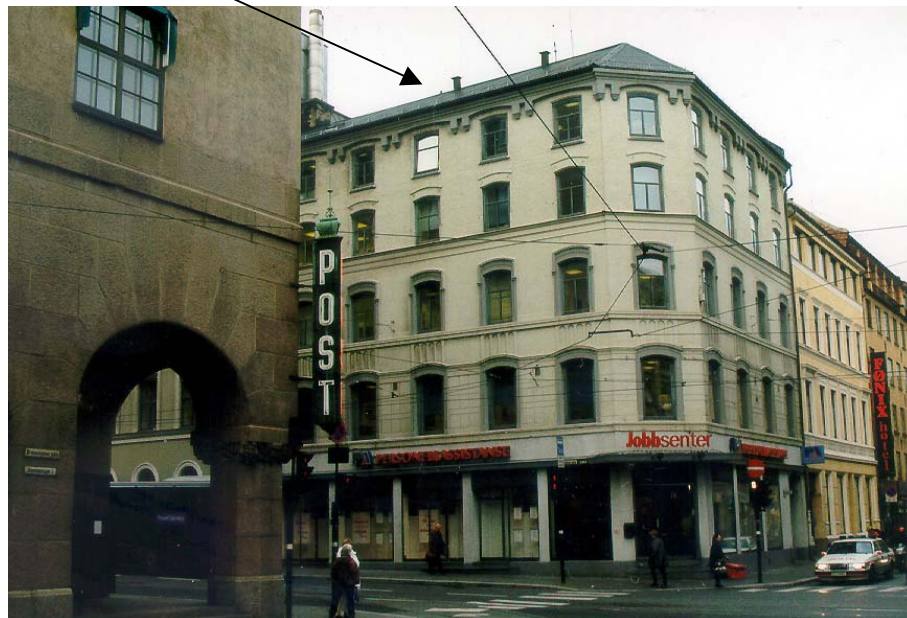
## 6.11 Prinsens gate 5

A fire destroyed the whole block between Dronningens gate and Kirkegata in 1858. The building of today was built in 1860, but some re-constructions have been carried out. The fourth floor was re-constructed in 1876 with larger windows. The ground floor was changed

both in 1891 and 1932, and modern windows were installed in 1980. The house is private owned and is used for shops and offices.

The building was built as The National Post Office in 1914-18 and 1921-24. The building is in a national baroque style. It was the main post distribution central up to 1995 and it is still one of the largest post offices in Norway (see the picture for Prinsens gate 5).

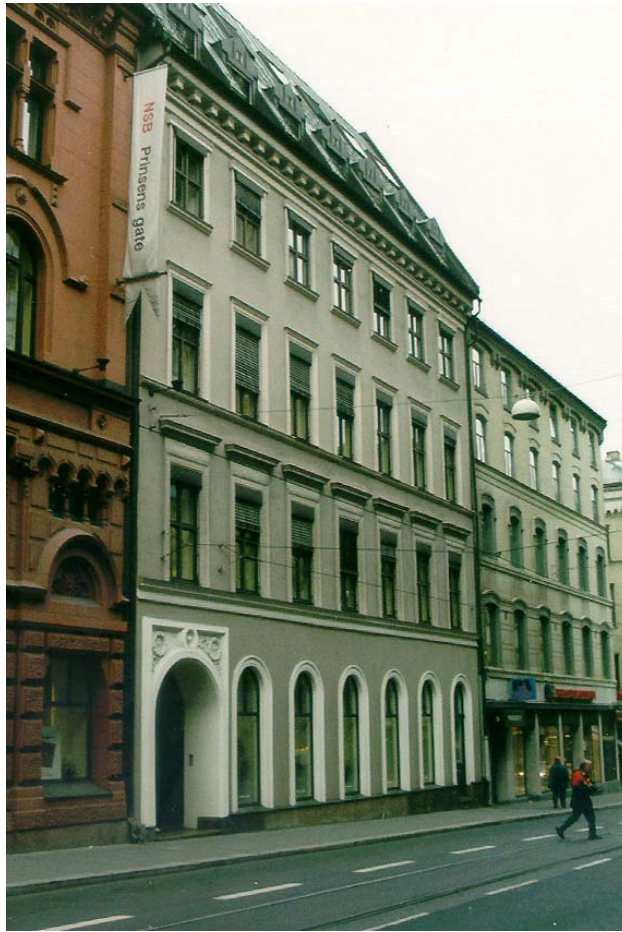
#### **6.12 Prinsens gate 7**

The building was built in 1860 as a private house with a repair shop in the backyard. A big re-construction was made in 1985. Only the façade was kept more or less as original. This re-construction was one of the cases that started the process for the later protection act for the area. The building is private owned and is used for offices.

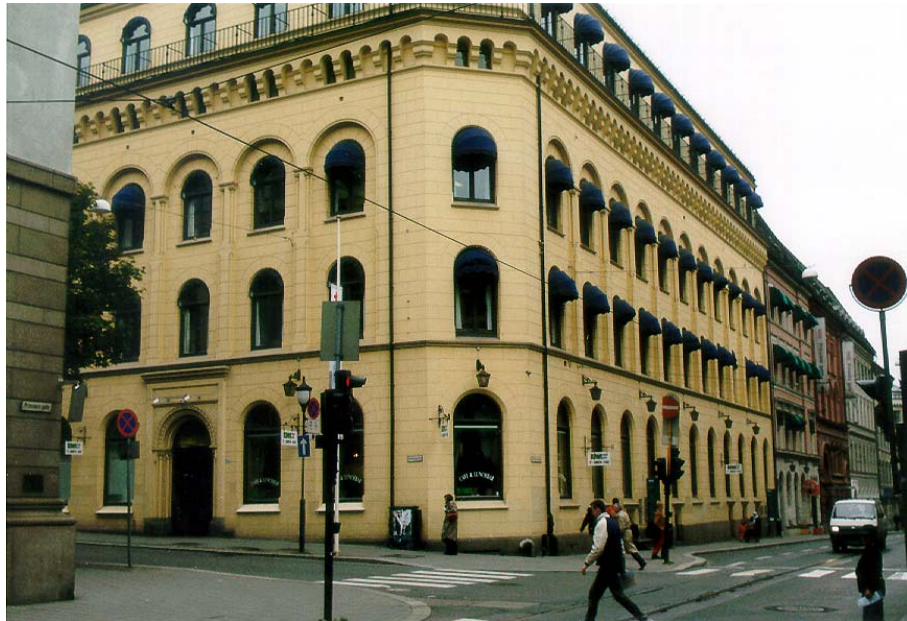
## 6.15 Kirkegata 24

The building was built as a bank in 1858-60 in neo renaissance style. The building also had offices for the Norwegian Telegraph. In 1926 the fourth and fifth floor were added. The building is private owned and contains shops and offices today.

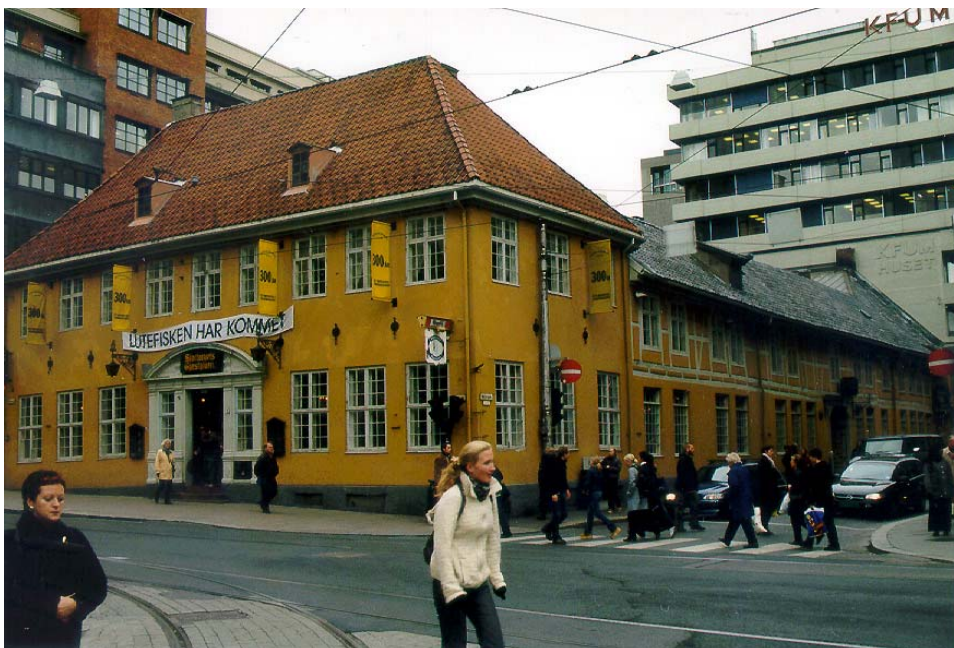
## 6.16 Grensen 1

The part of the building facing the street, Grensen, was built in 1700. The building is just outside the "Kristiania Kvadraturen", but is facing one of the most important streets for the traffic between east and west in Oslo, even in that time of the history. Originally it was a private home, but was changed to a hostel in 1860-ies and two wings were added. The hostel has included some sort of restaurant from 1863. A restoration back to its original style

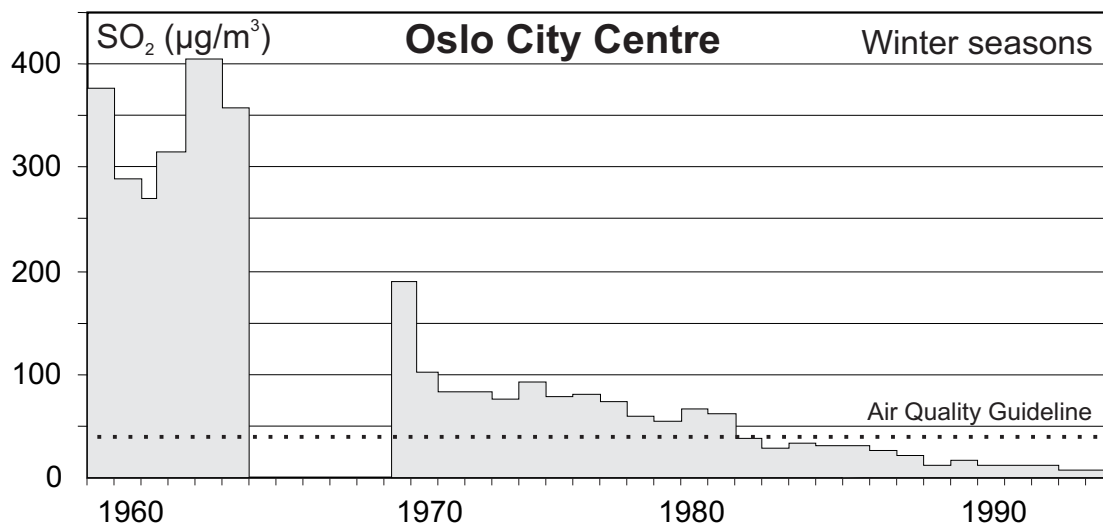
Figure 2: Winter concentration of SO<sub>2</sub> in Oslo city from 1958 to 1995. The Norwegian recommended Air Quality Guideline is given (Larssen, 1998).

As seen in Figure 2 a great improvement has been obtained for the SO<sub>2</sub> pollution during the last part of the 20<sup>th</sup> century. The main pollution problem in Oslo today is linked to particles from traffic and heating with wood stoves during the winter and NO<sub>2</sub> mainly linked to the traffic. Before 1990 the main traffic between east and west went through Rådhusgata. In 1990 a tunnel was built to reduce the traffic impact in the old part of the city.
